Taking the brakes out of the A/C Compressor

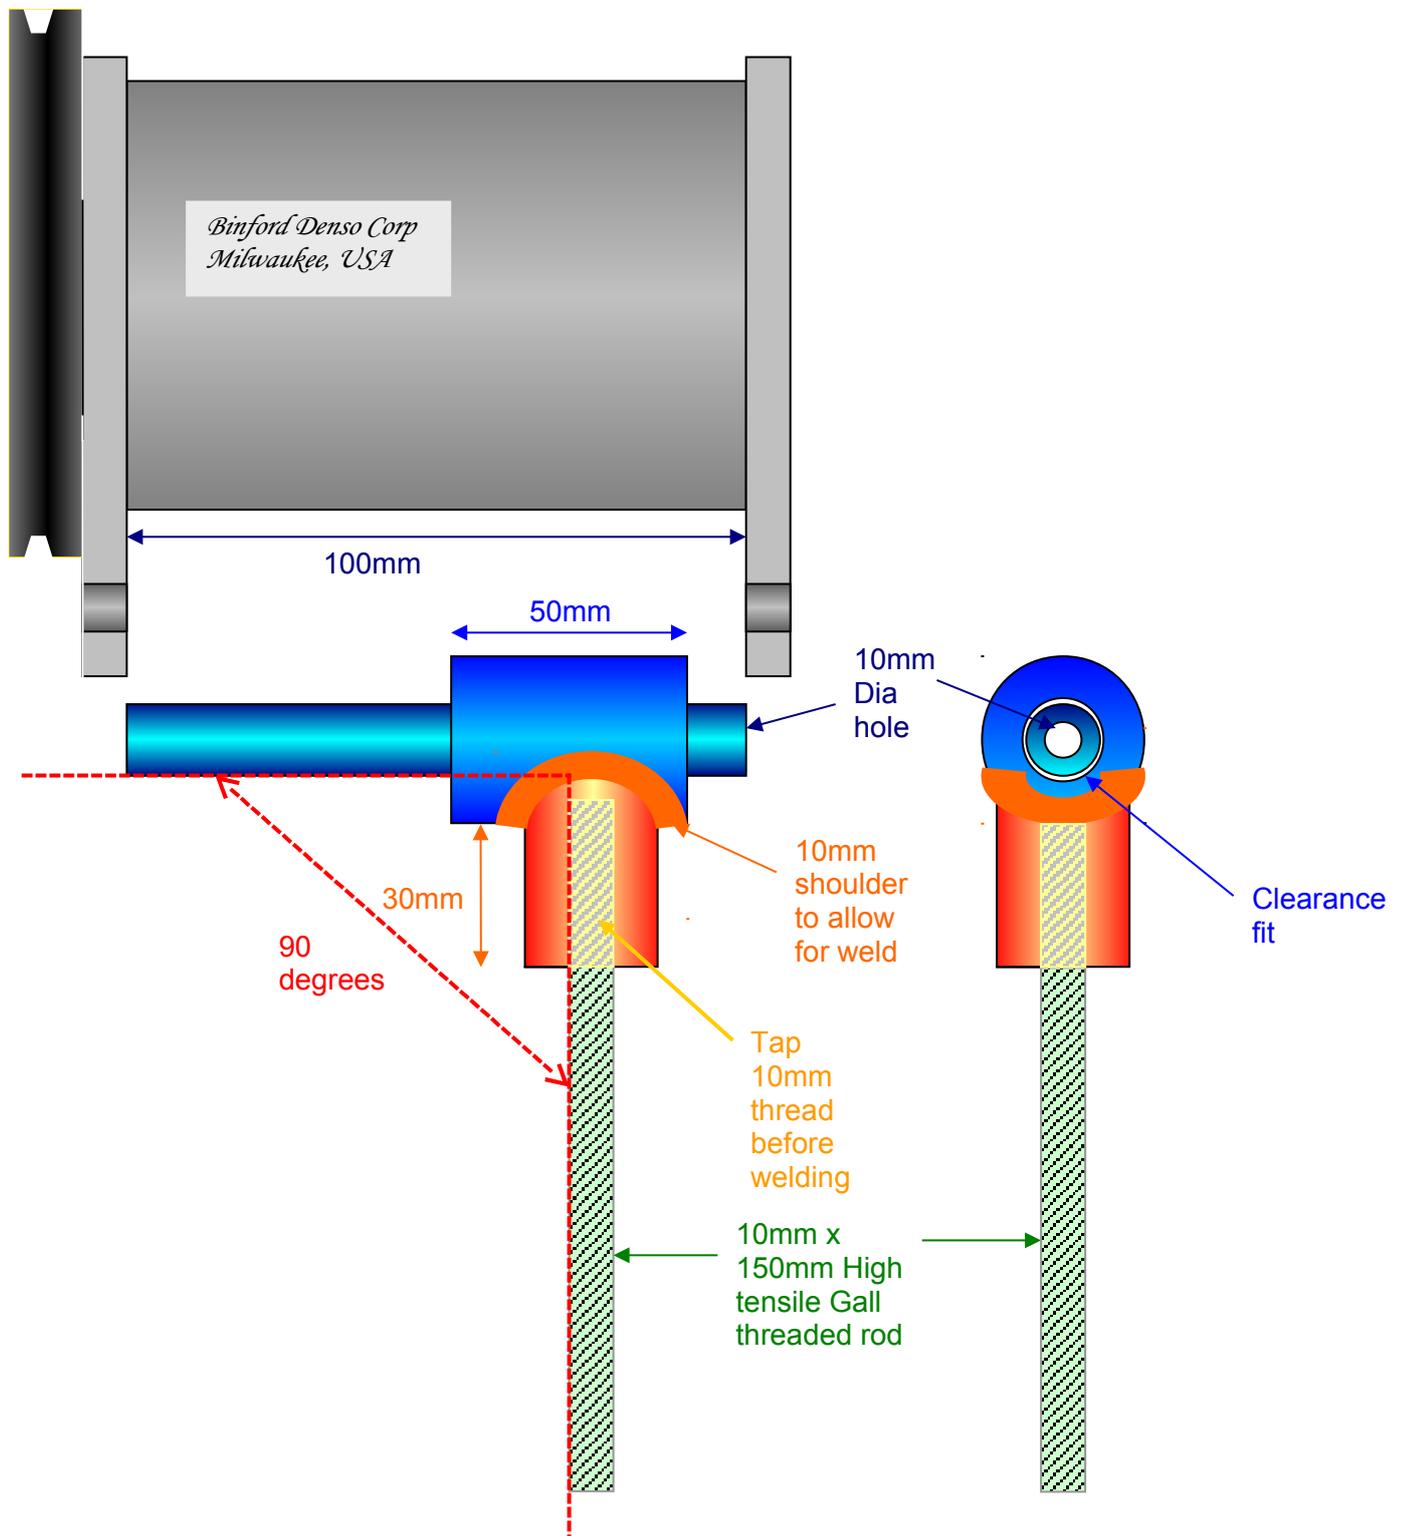
I came up with a design that used a short length of high tensile threaded rod for the adjuster. The rod screws into the swivel section of the bracket for easy roadside replacement. If the rod work hardens and breaks I simply grab the vise grips and replace it with another piece of threaded rod, pre cut and stashed in the trucks on board spare parts bin.

Having a closer look at the problem I realized that the threaded section needed to self align both longitudinally and rotationally after its compressor attachment bolt was tightened up. This would completely eliminate the side loads that broke the threaded section of the original bracket. Again I grabbed the verniers and measured the gap between the two Compressor mounting lugs. Have a look at the drawing for details. You should be able to take this drawing to any fabricator and get one made. Just get him to measure up your compressor, as a little wear will change things somewhat.
