## 6) Part 1: Burnt-Out Alternator Cabling

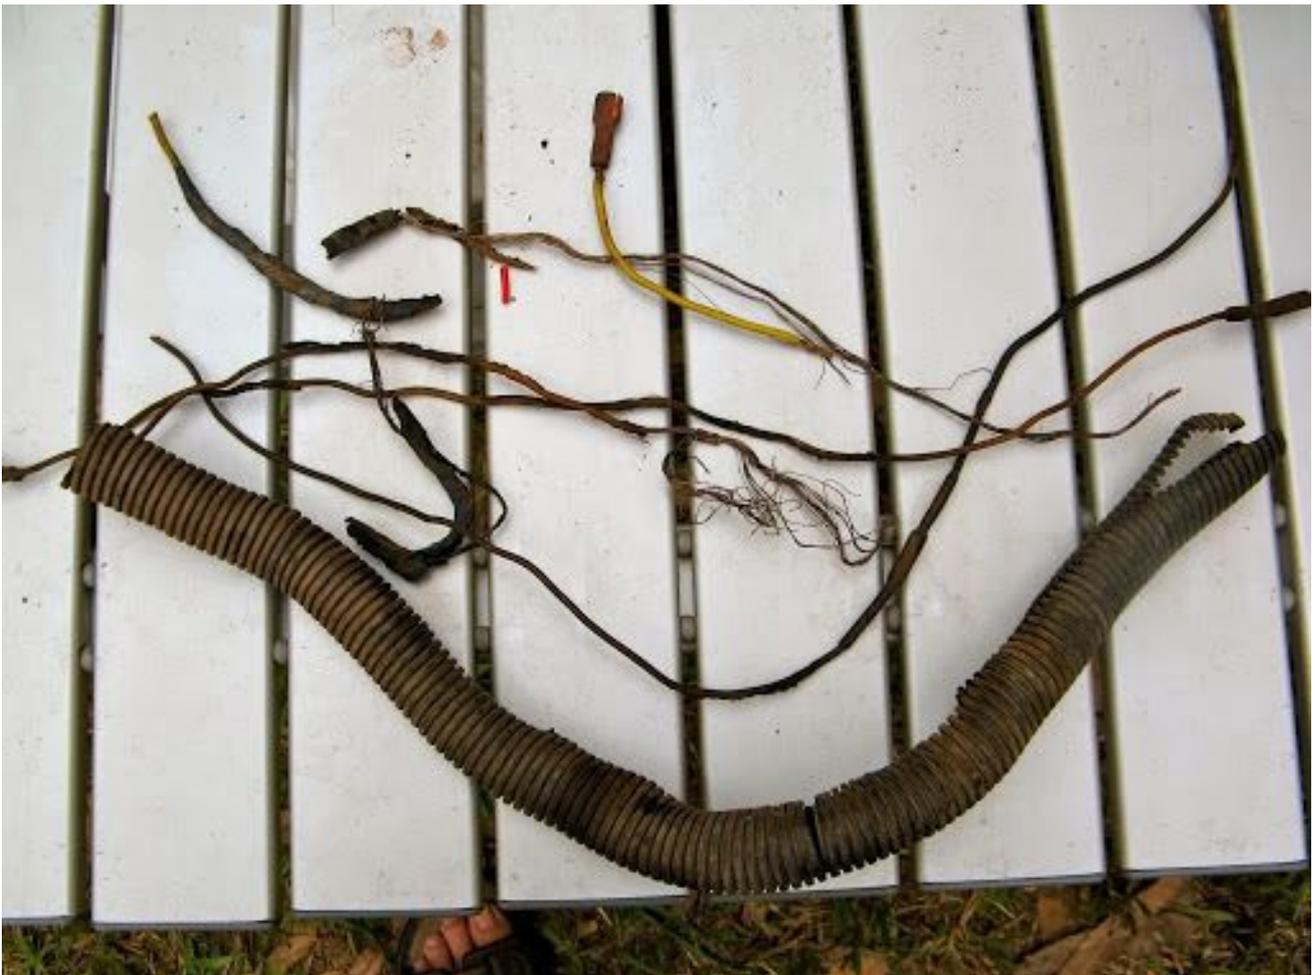
After taking the drivers seat out and removing the engine side panel I noticed some burnt wires from the alternator which had been tie-wrapped to the air conditioning hoses, themselves tie-wrapped to the chassis.

*Remains of the burnt out alternator wiring*

faced with a mass of burnt and melted wires. Some were burnt brown but still working, some were just bits of blackened copper wire with no insulation and a couple had disappeared completely, just leaving their terminals and blobs of molten copper.

The section of burnt cables started where they were bunched closely together in a plastic sleeve (which allowed them to overheat) and ended roughly where they were tie-wrapped to the air conditioner hose near one of the metal ferrules on the hose. These were close to the point where the valves are located to recharge the a/c gas, which we'd had done only a few weeks before.

What I think had happened was that the edge of the ferrule on the hose had rubbed on the cables and shorted one of them to either another wire, or the

chassis. The hose ferrules were not grounded in themselves, they might have also been touching the chassis. Maybe the act of re-gassing the air conditioning had disturbed the wires and hoses and caused a partial penetration of the insulation on some wires, and subsequent vibration had finally caused the short circuit. Since the wires came directly from the alternator connectors and were fairly low current signals there are no fuses to protect them, so we were fortunate that the short circuit was not sufficiently solid to cause damage to the alternator itself.

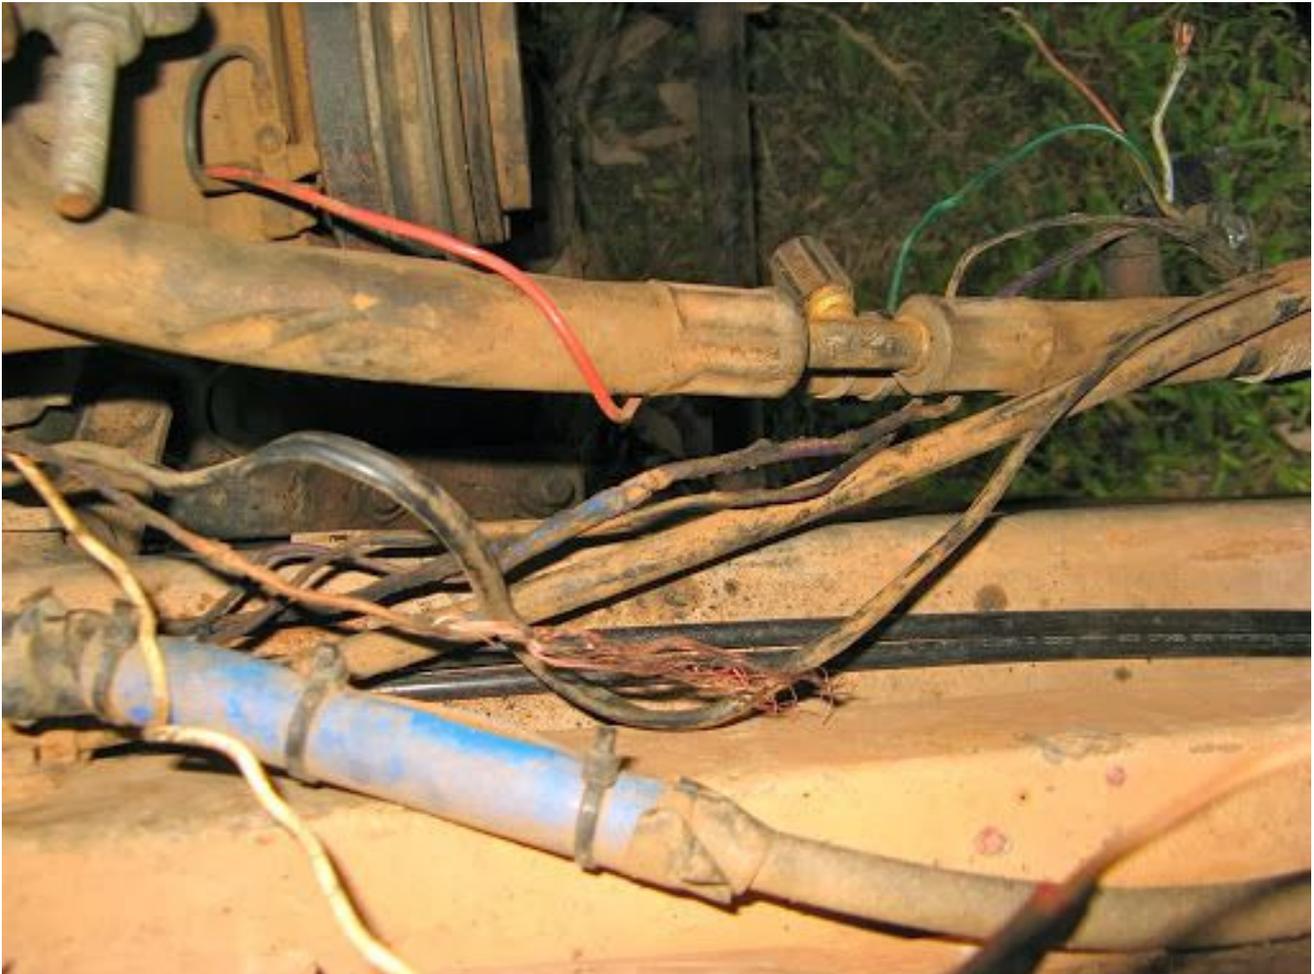
### *The wiring after being sorted out*

It took quite a while to unravel what I had left and what was missing. Fortunately I had an electronic version of the wiring diagrams on my computer and I traced the identifiable wires and replaced them with new wire and new terminals. But the thin wire from alternator to the rev counter had disappeared completely, so I had to re-run a new wire from the back of the rev counter to the back of the alternator.

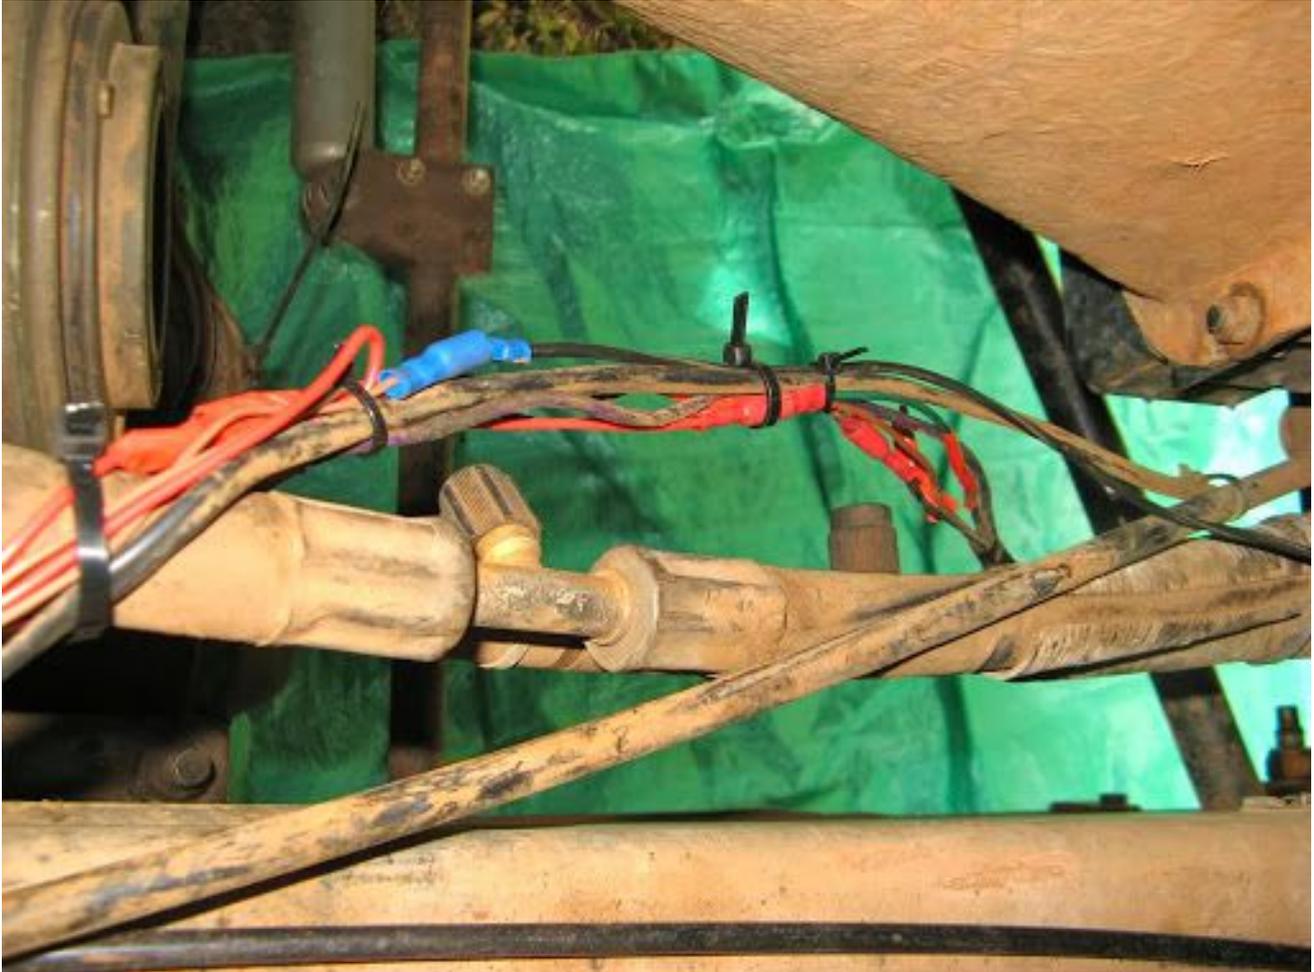
*The new wiring bunch, kept well clear of the hose ferrules*

Anyway, all was then well but to ensure it couldn't happen again, the new cable bunch was kept well away from the hose ferrules.
