## Vibrations from the Front Axle - GARP, The Great Axle Reconstruction Project

### Part 1 Repairing the Spindles

## Hubs and Spindles

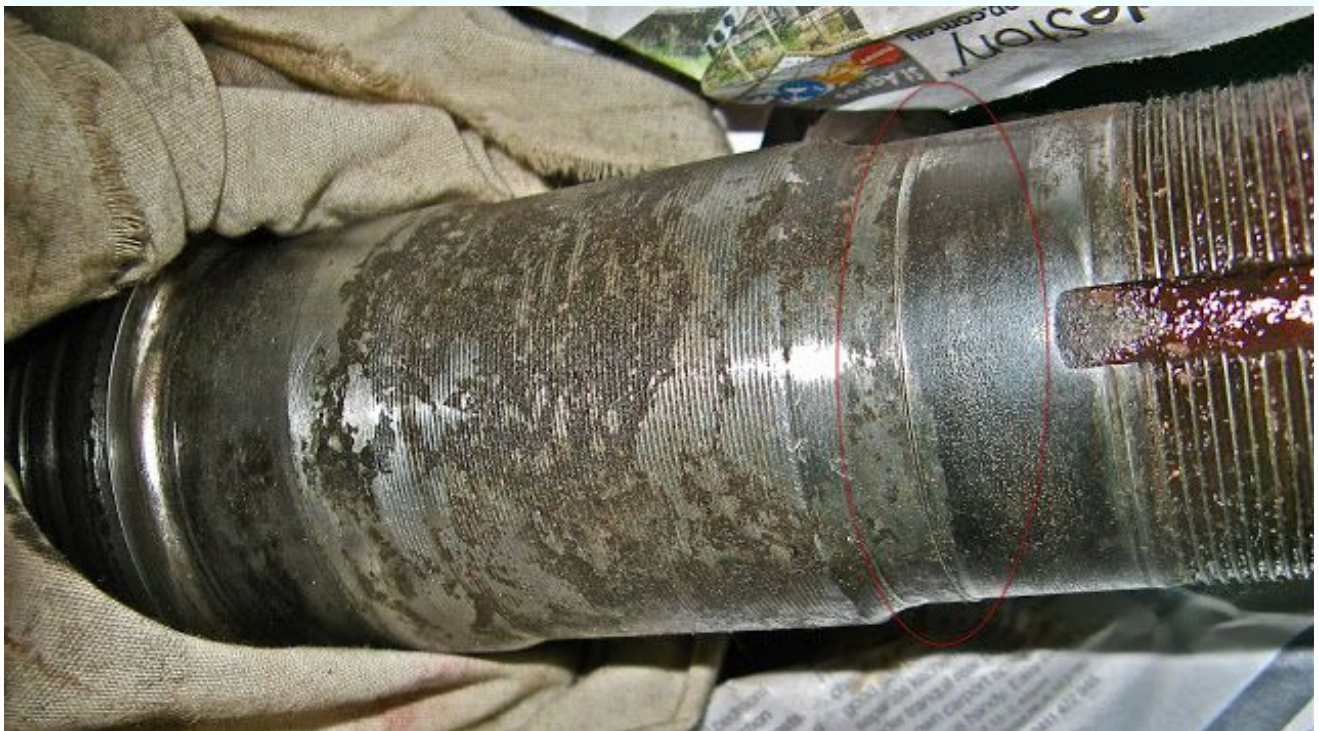
*Pic 1. The groove and ridge ringed on the spindle shaft. (Click to enlarge)*

It only took an hour or so to get to the heart of the problem, the outer bearing shell had indeed been rotating on the spindle and worn a groove (about 0.5 mm deep), so that the bearing was a fairly loose fit on the shaft. A ridge had also developed which prevented it from sliding freely, and this would affect the bearing pre-load adjustment as well. See ringed area on Pic 1.

So I investigated a repair process. I found a company in Adelaide (Adelaide Grinding) that would deposit a coating of metal on the shaft (by replating or metal spraying) and then regrind the bearing surfaces to their original dimensions. Since I wanted to do this only once, I also had the inner bearing surface treated at the same time, even though it wasn't as badly worn. Even better, the total cost was less than a quarter of the new spindle price.

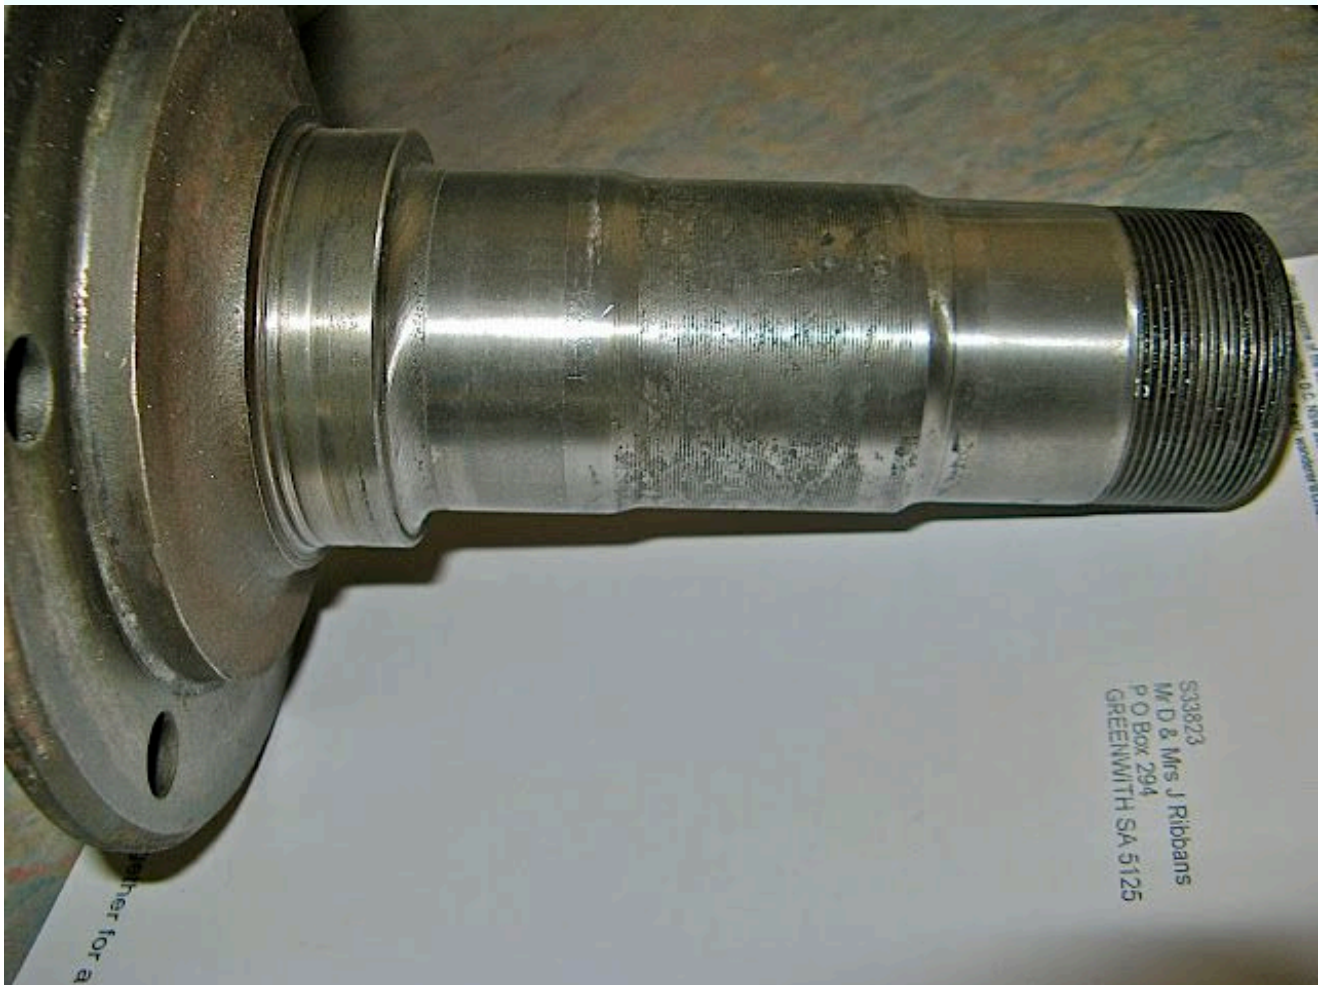
*Pic 2. The repaired spindle. Bearings are a good tight slide fit on the reground shafts.*

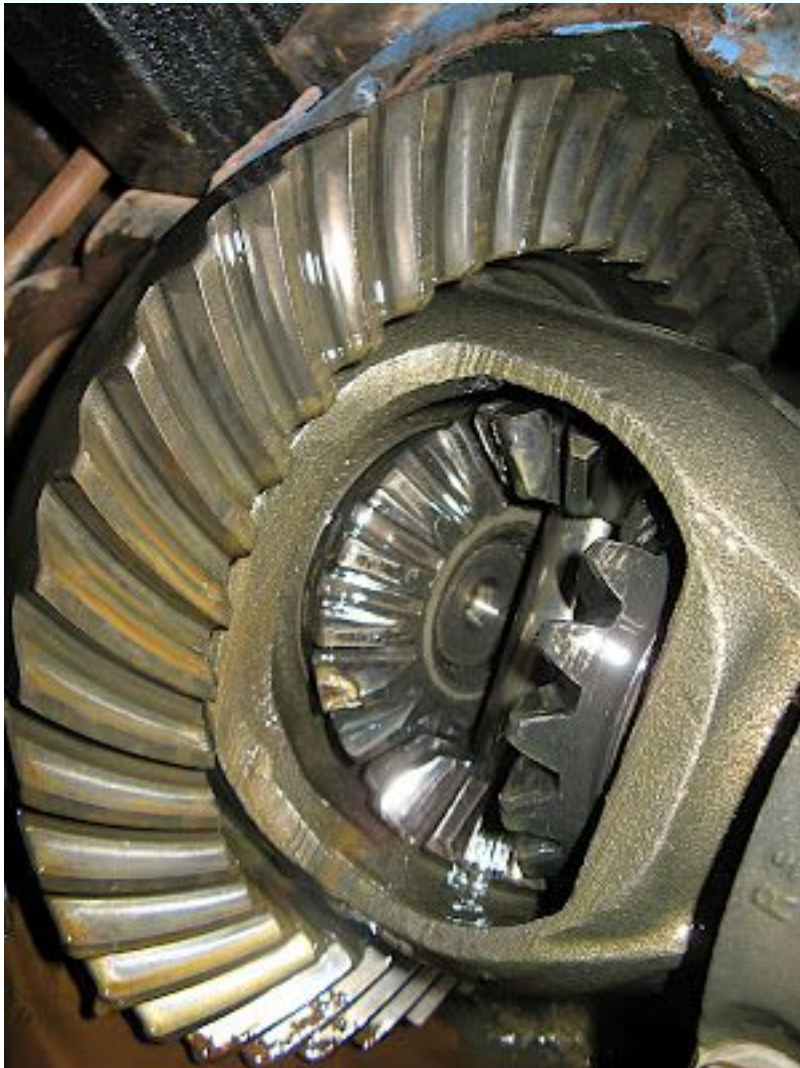
My heart sank as I knew what that would mean, and sure enough, when I removed the cover and turned the inner gears around there was one with part of its tooth missing.

*Pic 3. Toothache in the differential.*

This was also the unexpected opportunity I had been waiting for to replace the inner axle oil seals which are only accessible when the diff is removed. Muddy water from Kimberley creek crossings had got into the diff housing past the worn seals and laid at the bottom of the housing. This had caused surface rusting and pitting on some of the crown wheel teeth and bolts, since the front diff is stationary for much of the time.

So, buoyed with the negligible enthusiasm which stems from having reluctantly removed the diff, I went on the hunt for replacement gears, and once again in the US they are easy to come by, but not so easy in Oz. They are available from a few auto parts companies specialising in American vehicles, (eg [here](#) and [here](#)) but to be sure I got Oka compatible components, I acquired a second hand set from Paul Nott at [East Coast Oka](#) in Melbourne (which turned out to be a lot less worn than my original set). With some replacement oil seals on the way from Oka in Perth I am now able to start GARP, the *Great Axle Reconstruction Project*.

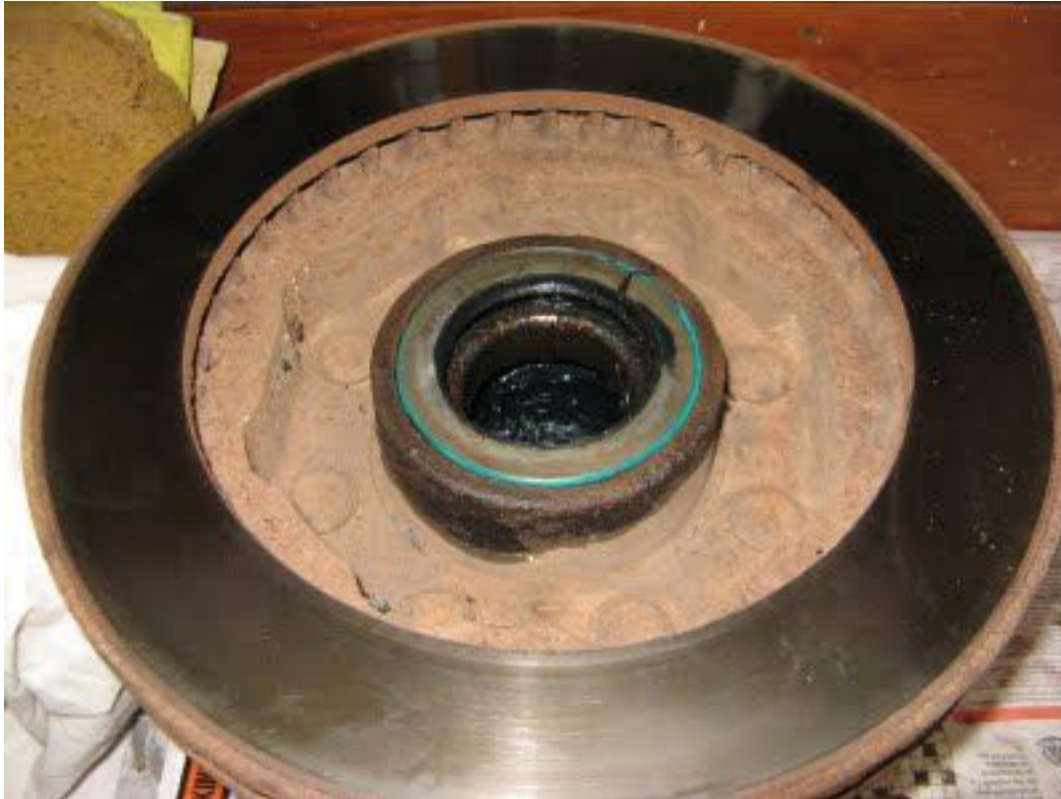
*Oil seal inserted into the rear of the hub.*

If the hub and bearings can be successfully located on the spindle without jamming, a new oil seal can be pressed into the rear of the hub, by gently tapping around the edge with a heavy hammer until it's flush with the hub casing. Don't knock dirt from the back of the hub into the bearings.

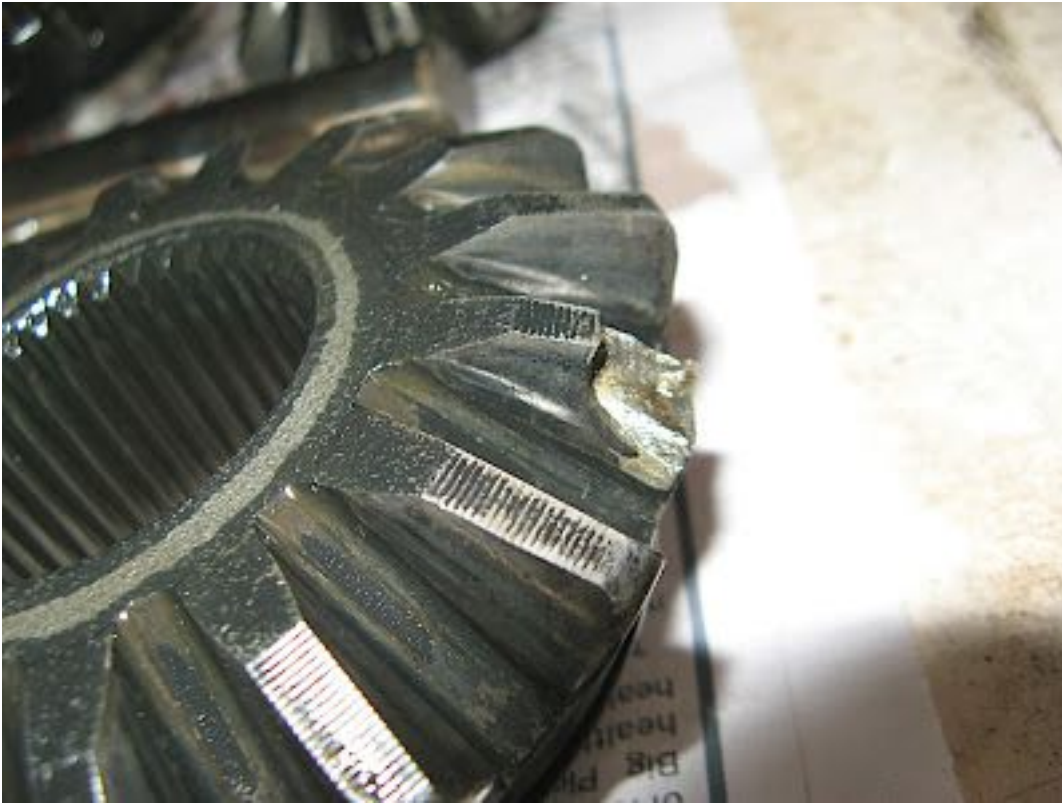
A close up of the offending tooth.

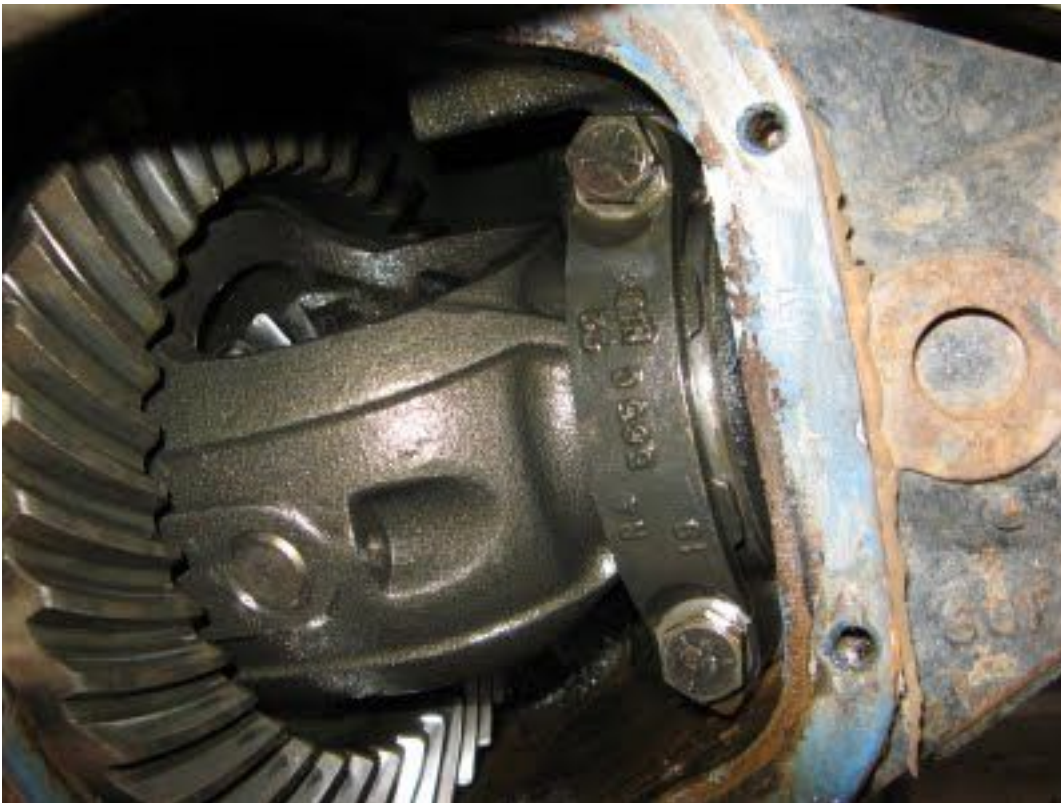
The bearing cups had previously been rotating in their housing and caused a burn mark so I applied some Loctite 641 (bearing retaining compound) to the housing and bearing caps to stop them rotating.

*The differential installed in the carrier.*

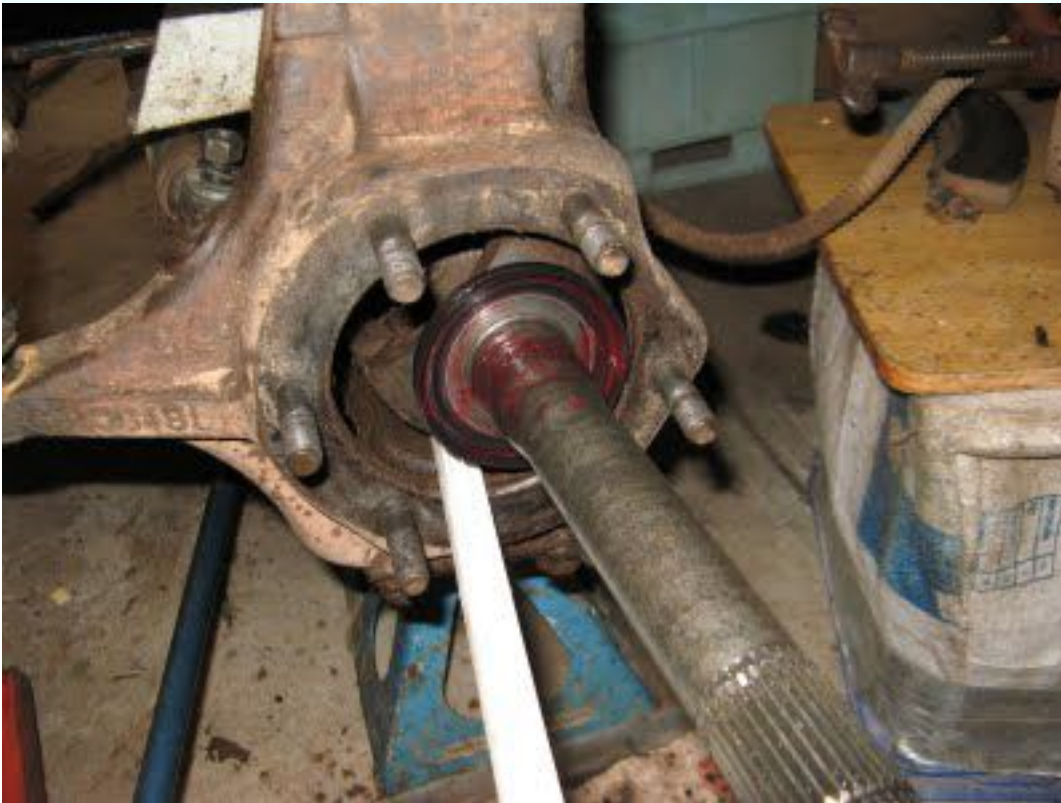
*Using a length of plastic strip to keep the drive shaft out of the dirt. The oil seal has also been replaced.*

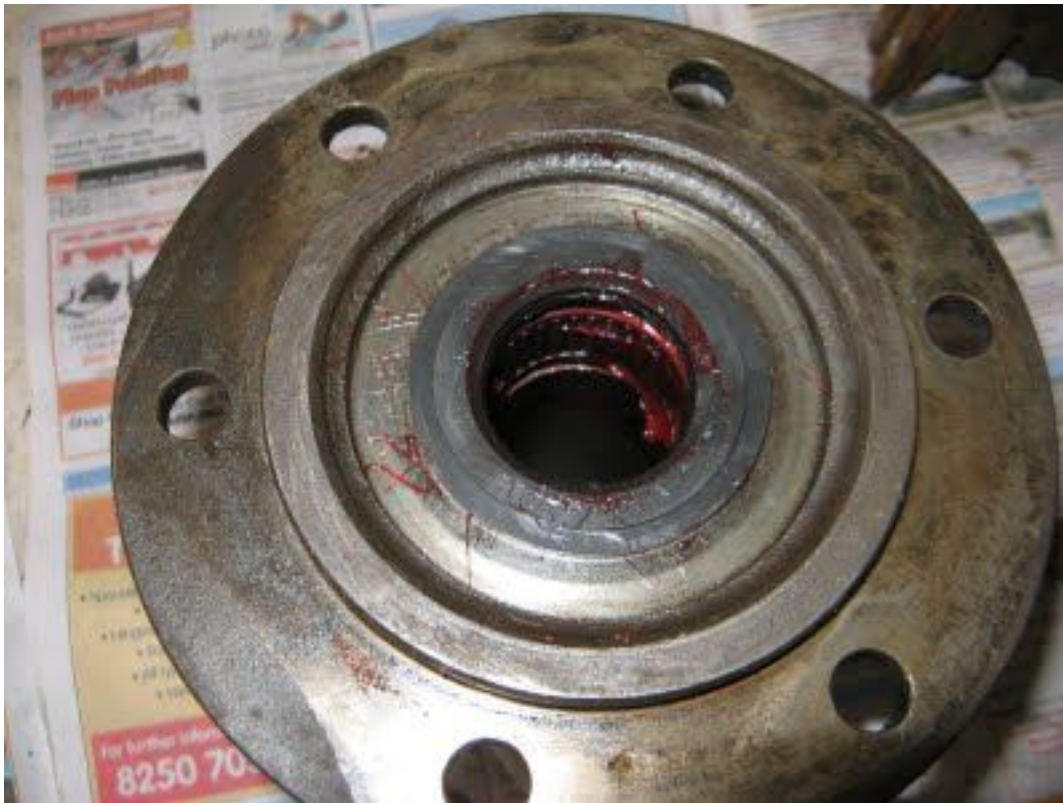
*Needle bearings greased and new oil seal fitted into spindle.*

Before refitting the spindles, I levered out the old oil seals (which had broken in 2 anyway), flushed out and re-greased the needle bearings and tapped new oil seals into the back of the spindles.
