[Forum Home](#) > [OKA Maintenance](#) > One to watch

The old girl has spent much of its life on corrugated dirt roads. So it has a little bit more wear in places.

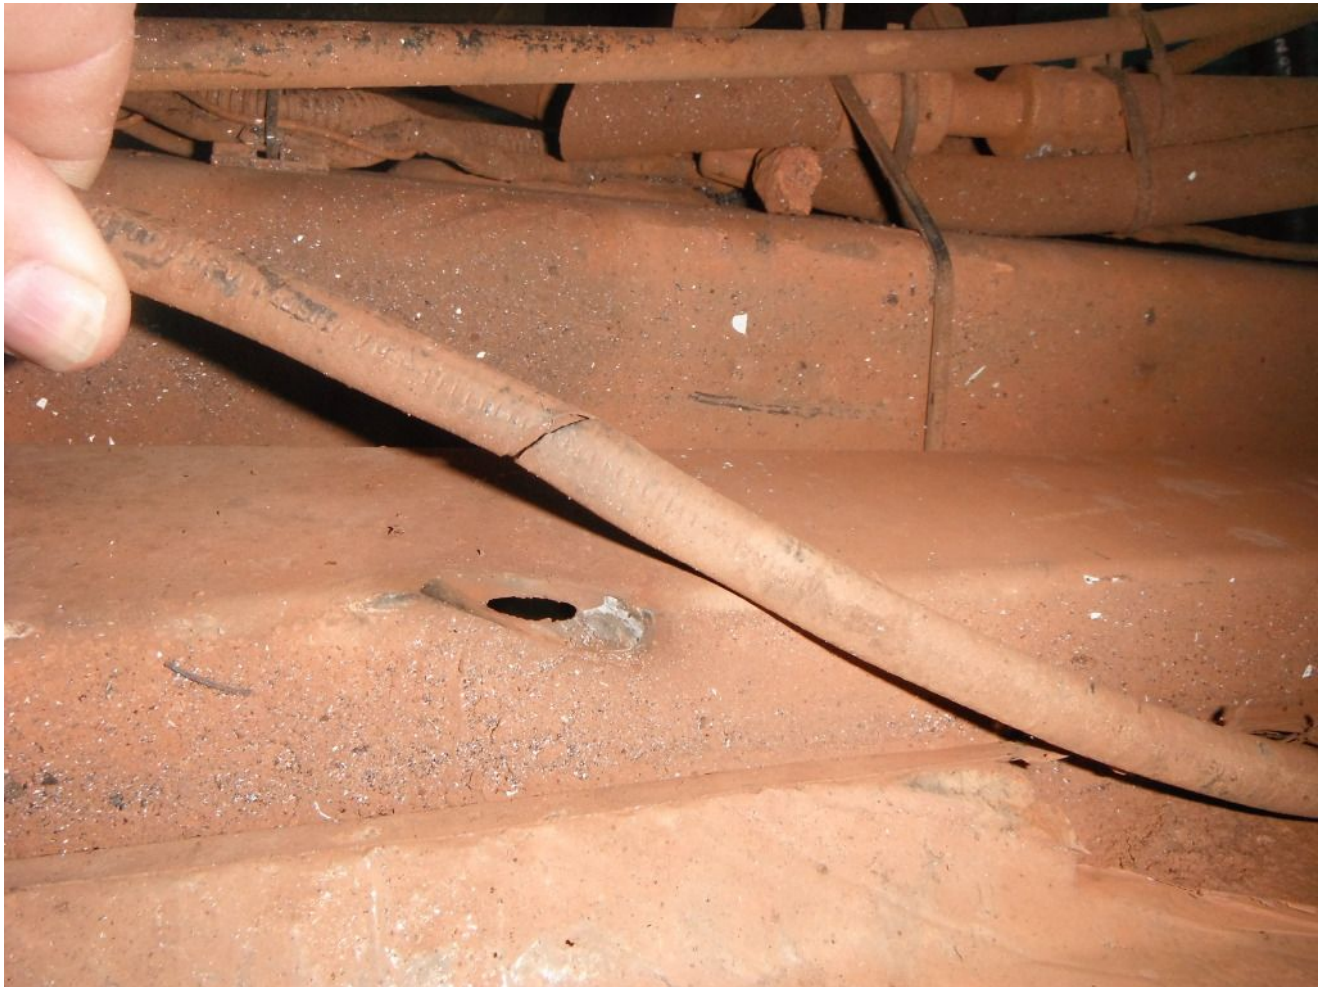
**Clutch Cable has rubbed through chassis**

You will probably find that the coating of mud and crap on the cable work as an abrasive, the rule in my book is nothing should be loose for more than 300 mm.....I looove cable ties, good

time to inject some fish oil inside the chassis  
Cheers,joe

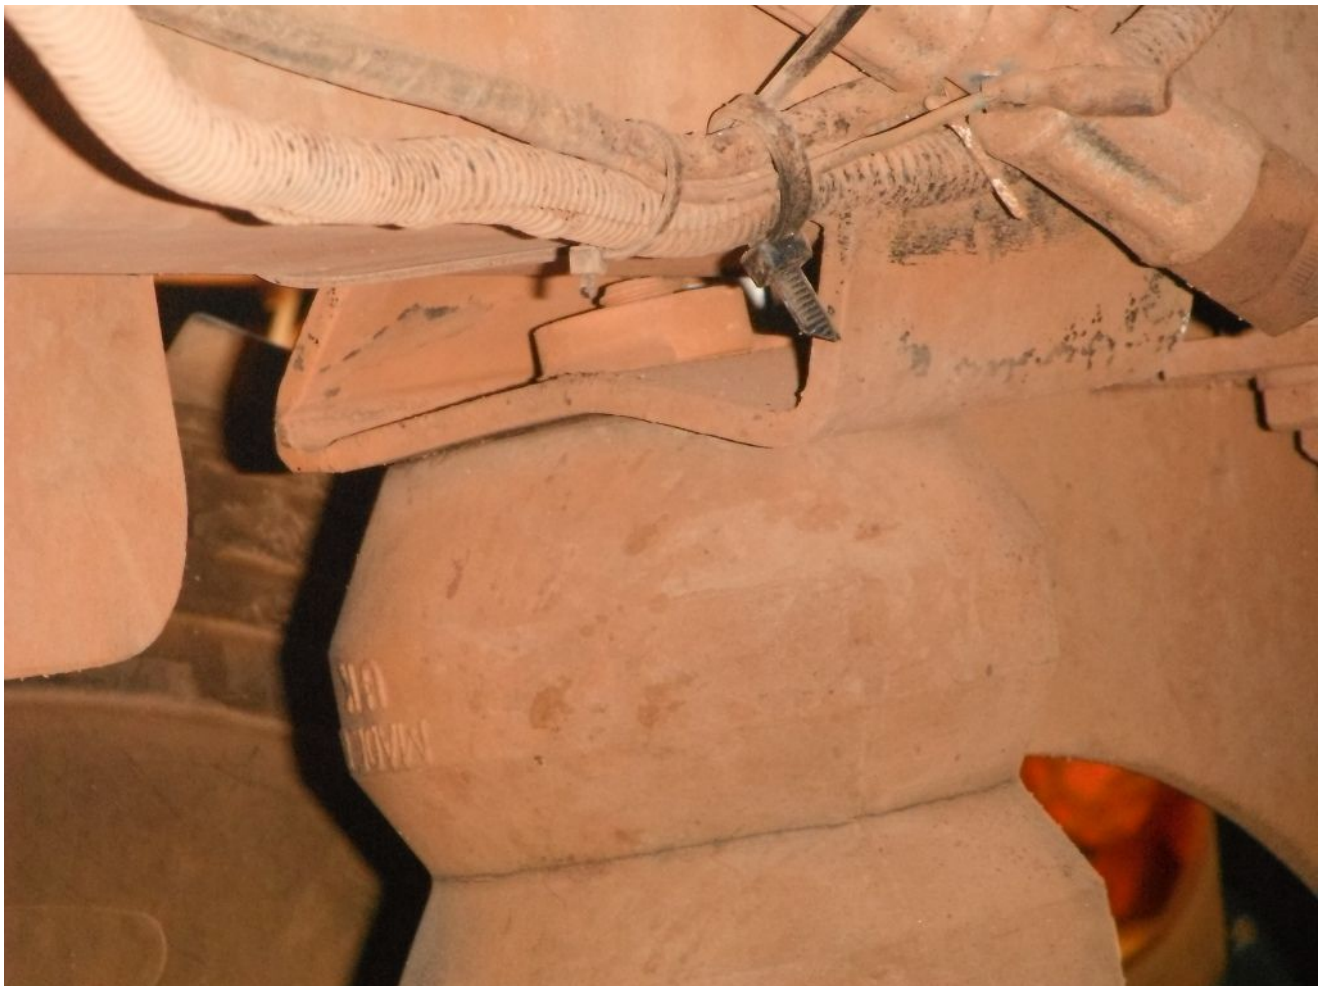
**RHS AEON RUBBER MOUNT**

Must have take one hell of a bump to bend that.....
