## Vibrations from the Front Axle - GARP, The Great Axle Reconstruction Project

### Part 1 Repairing the Spindles

## Hubs and Spindles

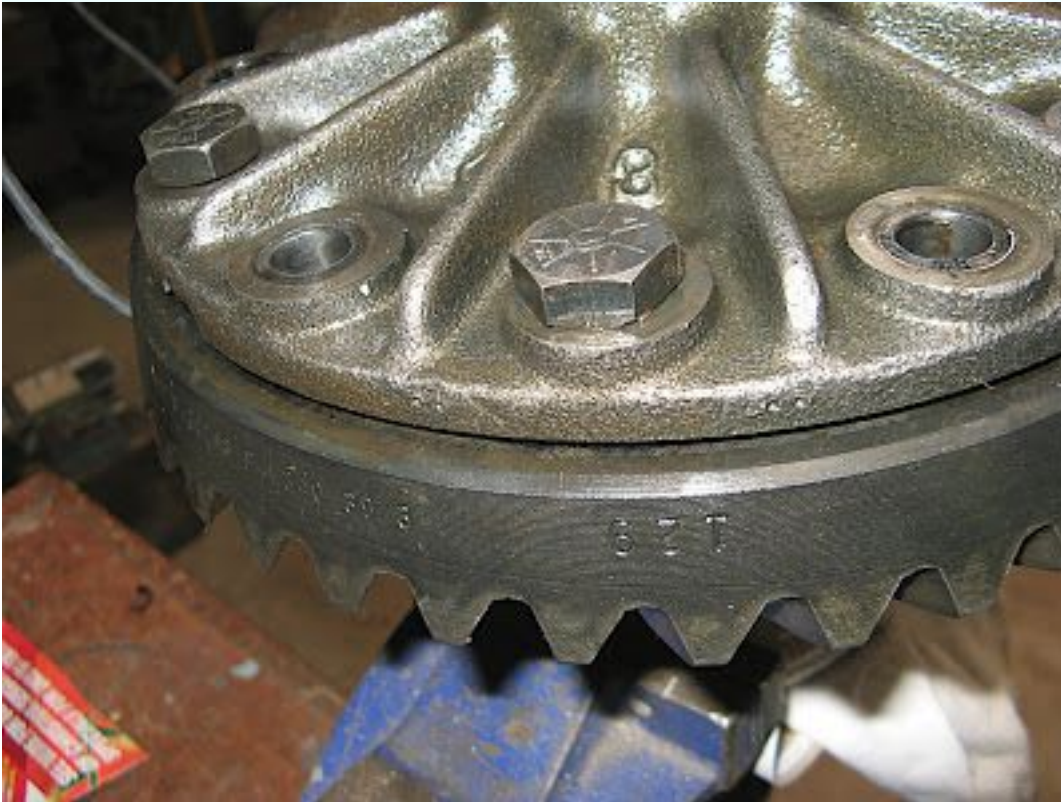
*The Ring Gear being removed.*

Removing the ring bolts was easier than anticipated since they should have been torqued to 130 ft-lbs (176 Nm) and Loctited too. I left four of the bolts partly in place and tapped them

with a hammer to free up the ring gear, which wasn't very tight anyway. I moved the carrier from the vice to the workbench and then removed the last 4 bolts whilst holding the ring away from any hard objects. I didn't want to have to replace that as well, since ring gears only come as matched pairs with the pinion, which would have made it a much more difficult (and expensive) job.

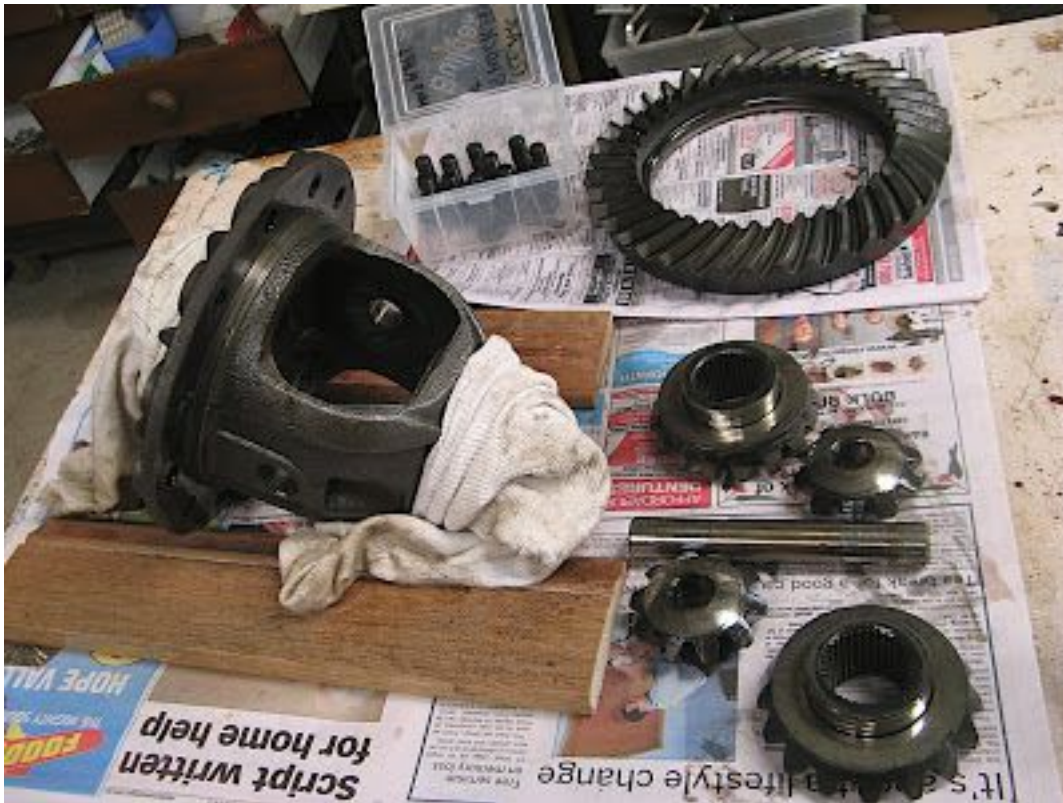
The diff in pieces ready for reassembly.

I smoothed the rusted and pitted surfaces of the ring gear with fine emery paper and WD40 and cleaned them off with Brake Cleaner fluid.

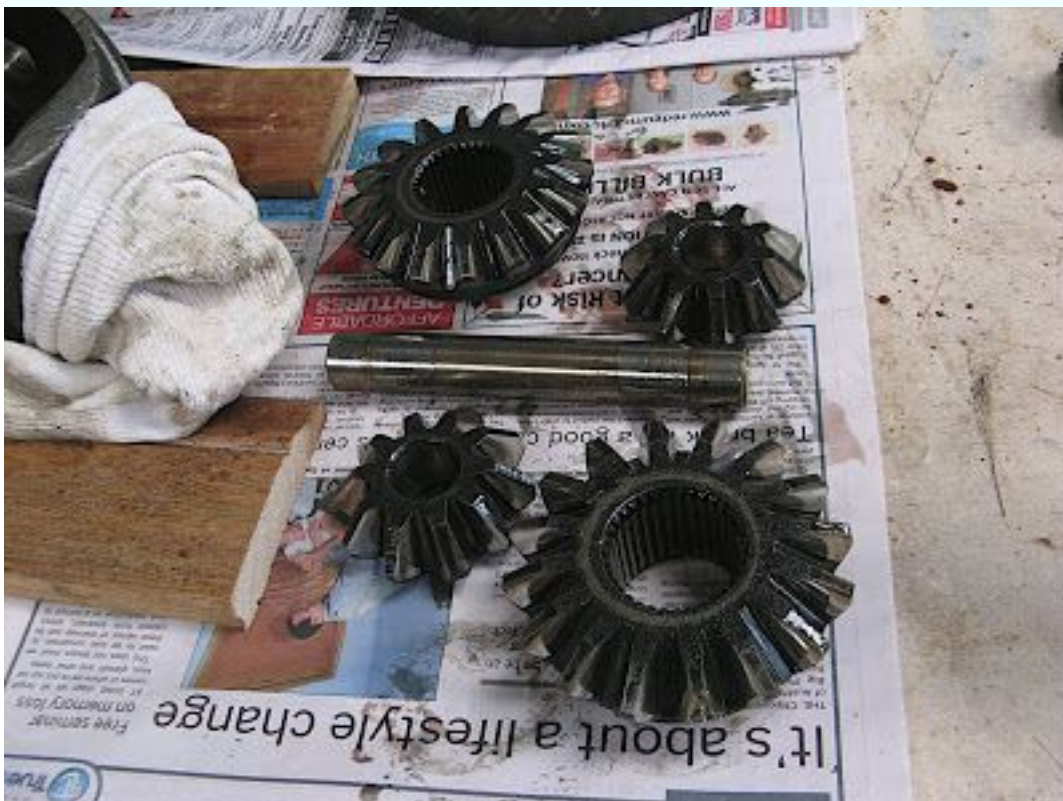
Differential Gear Set.

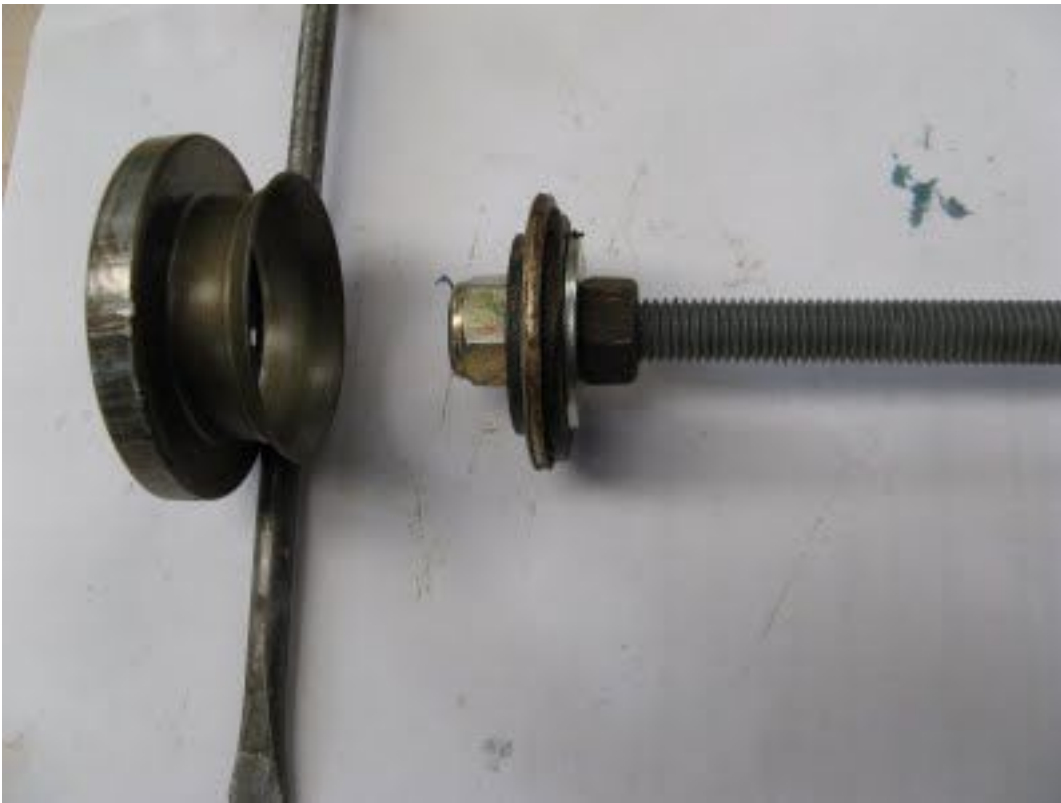
*The pusher for removing the inner seals and cleaning out the axle tubes.*

To remove the inner diff oil seals I built a pusher rod made of a metre of 12mm tapped rod with a large steel washer, just the diameter of the rear guide section of the seal, bolted to the other end. A few whacks with a heavy hammer and the seals popped out into the diff chamber. Other people have used a large socket and several extension bars to achieve the same result, but I didn't have the right size socket (or sufficient extension bars). The bar needs to be at least 1 metre long to remove the LHS seal.

This bar, with a sock tied over the washer, also makes a useful tool for cleaning out the oily/muddy sludge from the axle tubes.

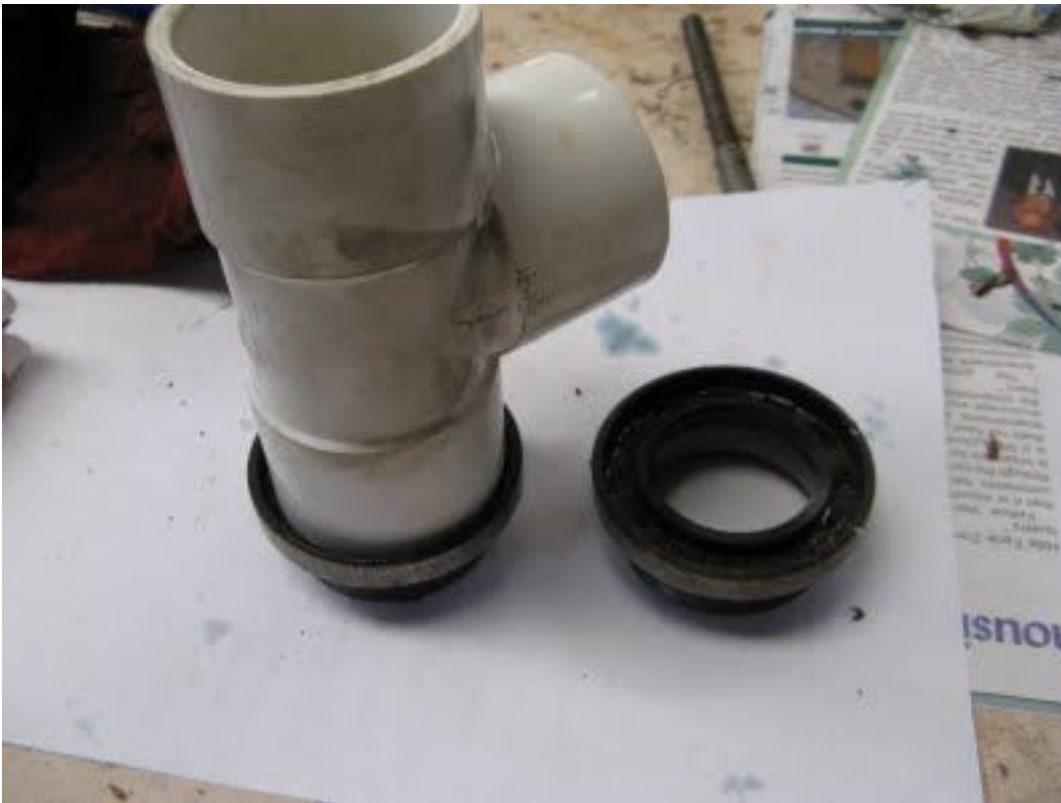
*A modified 40 mm high pressure water fitting would fit inside the body of the seal.*

To insert the seals I used a modified 40 mm high pressure water fitting, which just fits inside the seal body, to avoid damaging the plastic parts of the seal with a hammer. The fitting will need to be cut down to about 50 mm long to allow a hammer to be swung inside the diff housing. I drilled and fitted a long bolt to the side of the plastic fitting as a handle, to keep my thumbs well clear of the hammer. A suitable socket might also work. Alternatively a pusher tool could be made up as described in the Dana 60 manual. Any rust or corrosion around the seal location should first be removed and the surfaces smoothed down.

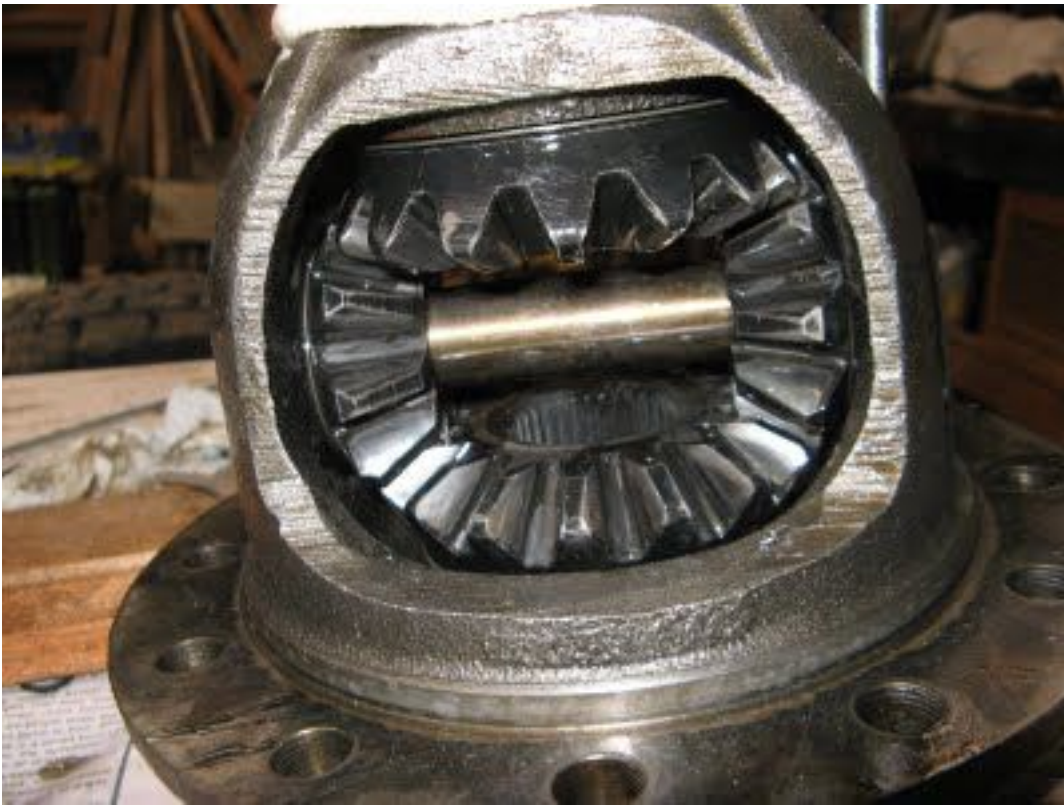
*Gears reinstalled in the carrier.*

You'll need about 15 fingers to hold the 4 gears and their thrust washers in the right place but it's not too difficult. Insert the side gears first on their washers, with the carrier horizontal so they can't fall out. Then insert both spider gears exactly  $180^\circ$  apart from either side of the carrier and walk them into the carrier case by turning both side gears in the same direction. If they are not exactly  $180^\circ$  apart on the side gears the cross shaft holes won't line up. I found it easier to slide the saucer shaped thrust washers in behind the spider gears *after* the gears were in place.

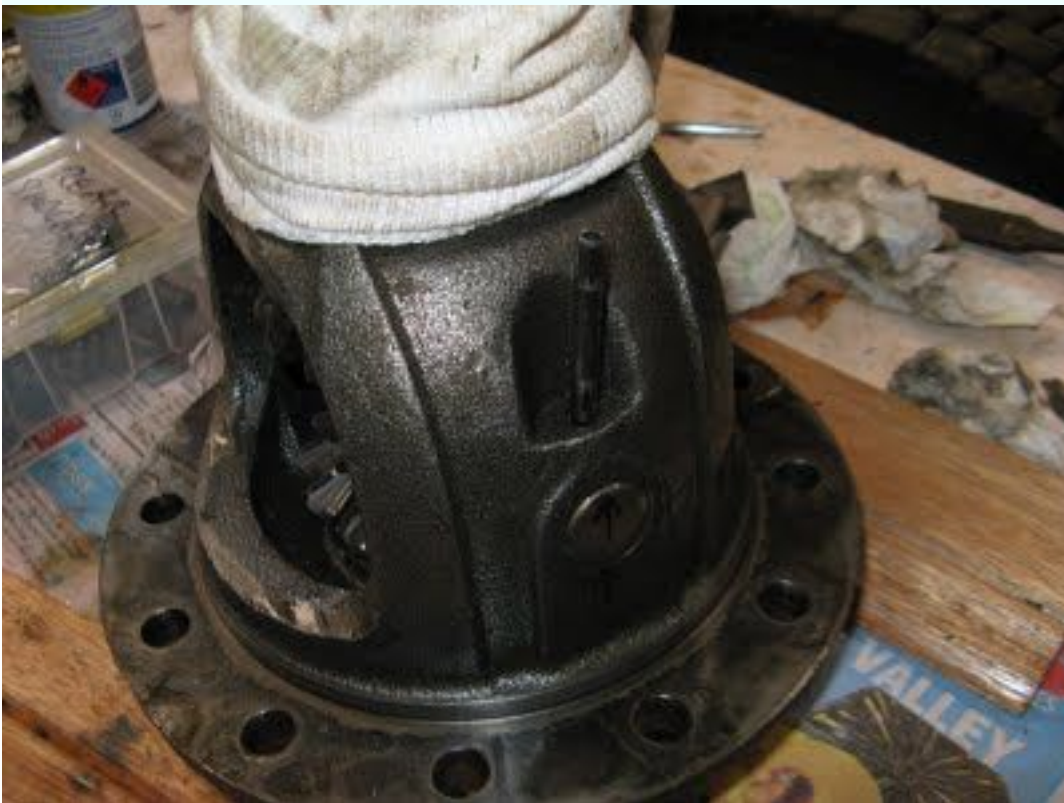
*Driving the Roll Pin home to complete the assembly.*

Once all the gears are in place, centre the spider gear washers with a finger and insert the cross shaft with the roll pin holes roughly in line. Use a thin bar to turn the cross shaft until the roll pin holes line up and drive in the roll pin. The differential gears are now complete, assuming they all turn smoothly.

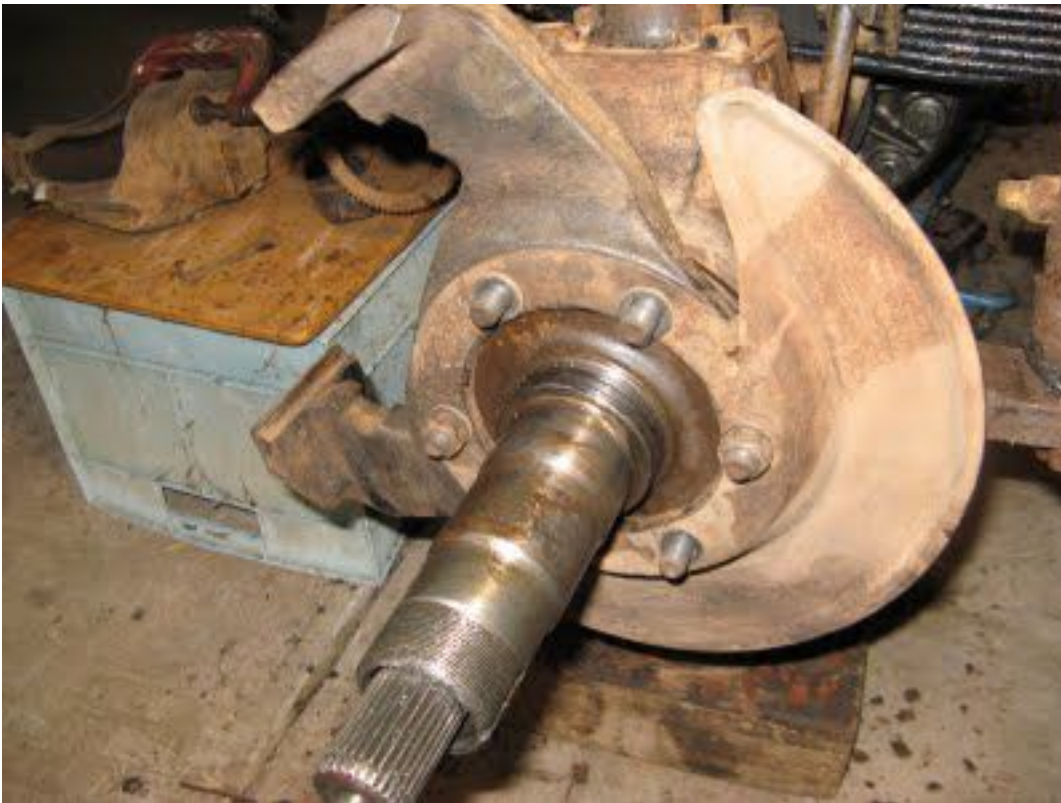
*Refitting the Spindle, drivers side.*

Wrong. There are pictures of the axle, spindle and hub arrangements and pictures of the brake rotor and calliper, but none showing both. Eventually I deduced that the spindle is attached direct to the steering knuckle with the brake calliper plate on next and the stone guard on last. It didn't look right, due to the cranked angle of the calliper plate and stone guard, but it was logical when I thought about it.

Loctite the spindle fixing nuts and tighten them to 65 ft-lbs. Once the hub is in place you can't reach them anymore.
