Bendix Hydroboost Repair

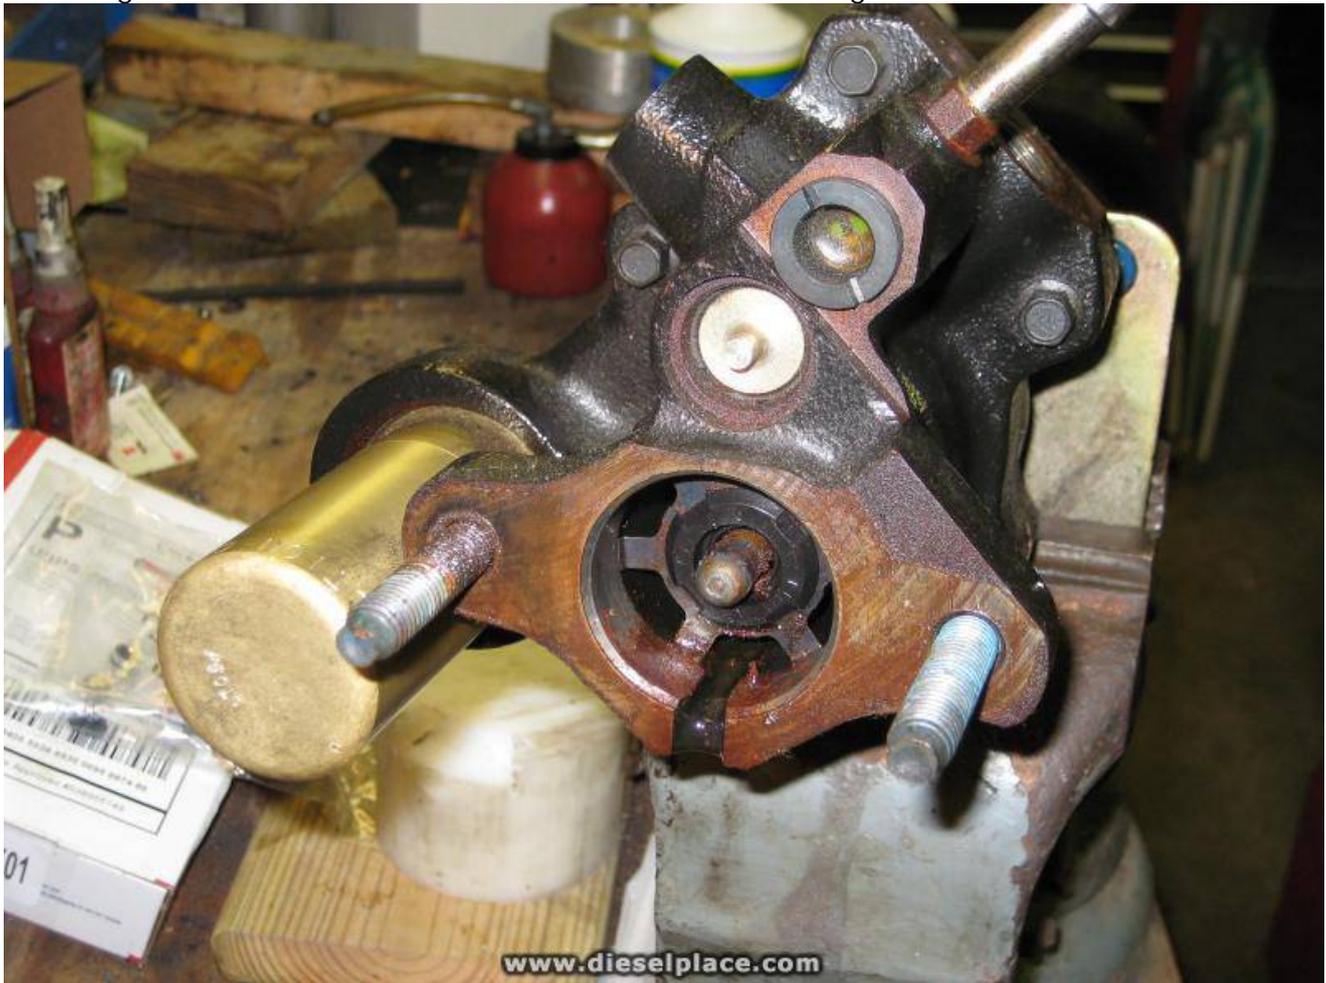
Pic 1 the leaky power piston seal... (probably master cyl too.)

The leaking power piston seal was quite obvious. This seemed to be a fairly new unit, but the power piston seal was quite brittle along the power piston. Maybe the brake fluid hardened the lips? (the OD of the seal was still pretty pliable, but the lips riding the piston were rough and brittle.)

I did not replace the check valve nor the dump valve. Again I think this unit was a recently replaced unit, but the leaking master cylinder and about 2 years of non use killed the power piston seal.

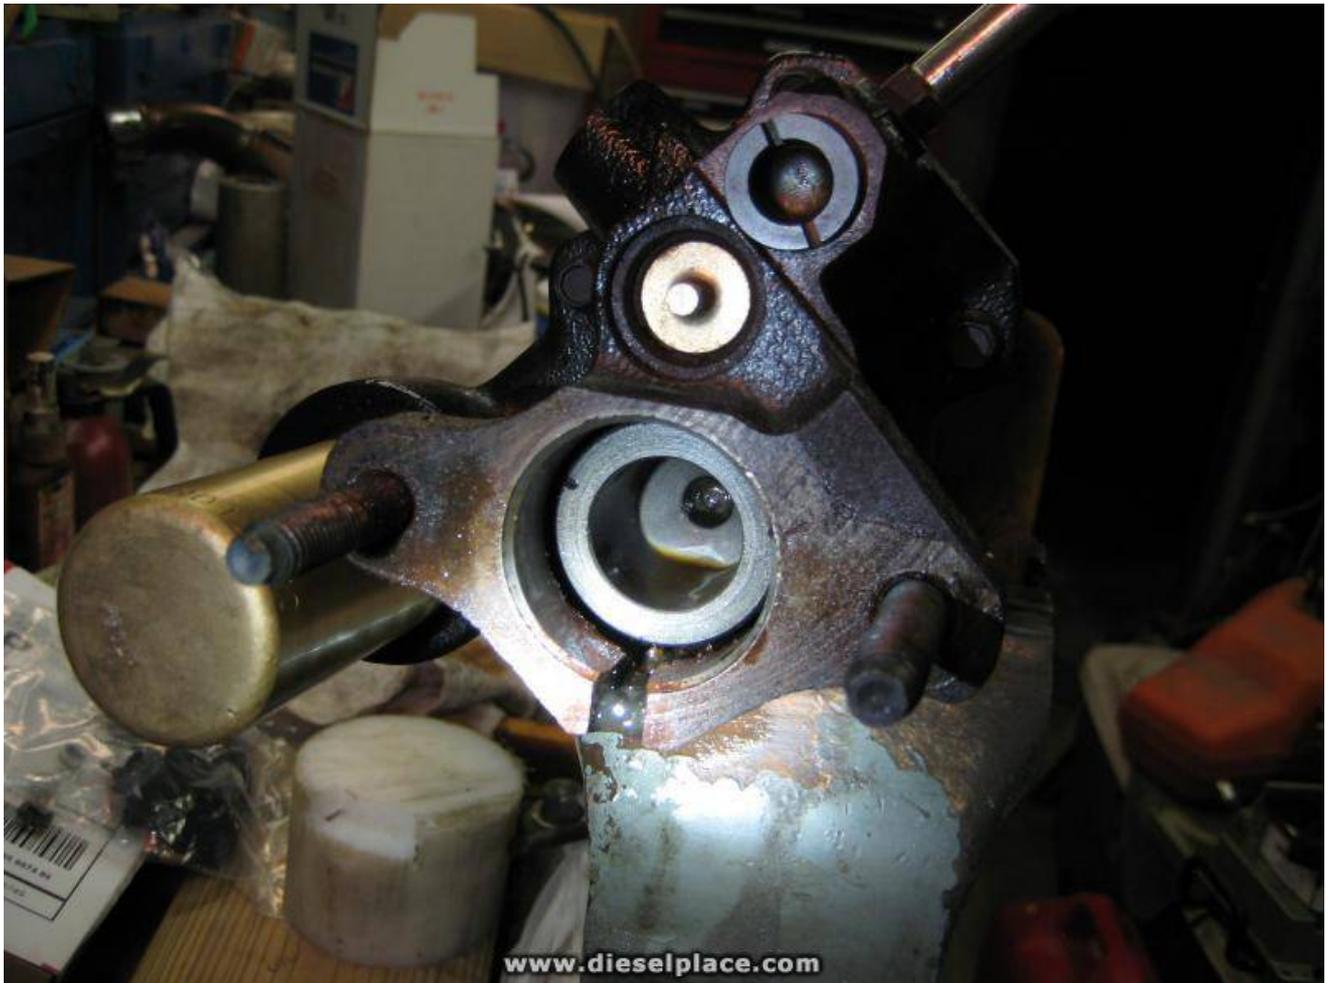
Pic 2 PS fluid after spider removal and MC actuator rod

The full kit has many parts. I bought it because I saw all the rust on our "spider" when we removed MC. This spider just supports the output rod to align with MC during installation. (surprisingly the kit did NOT come with the plastic center for that spider, but did have the new spider)

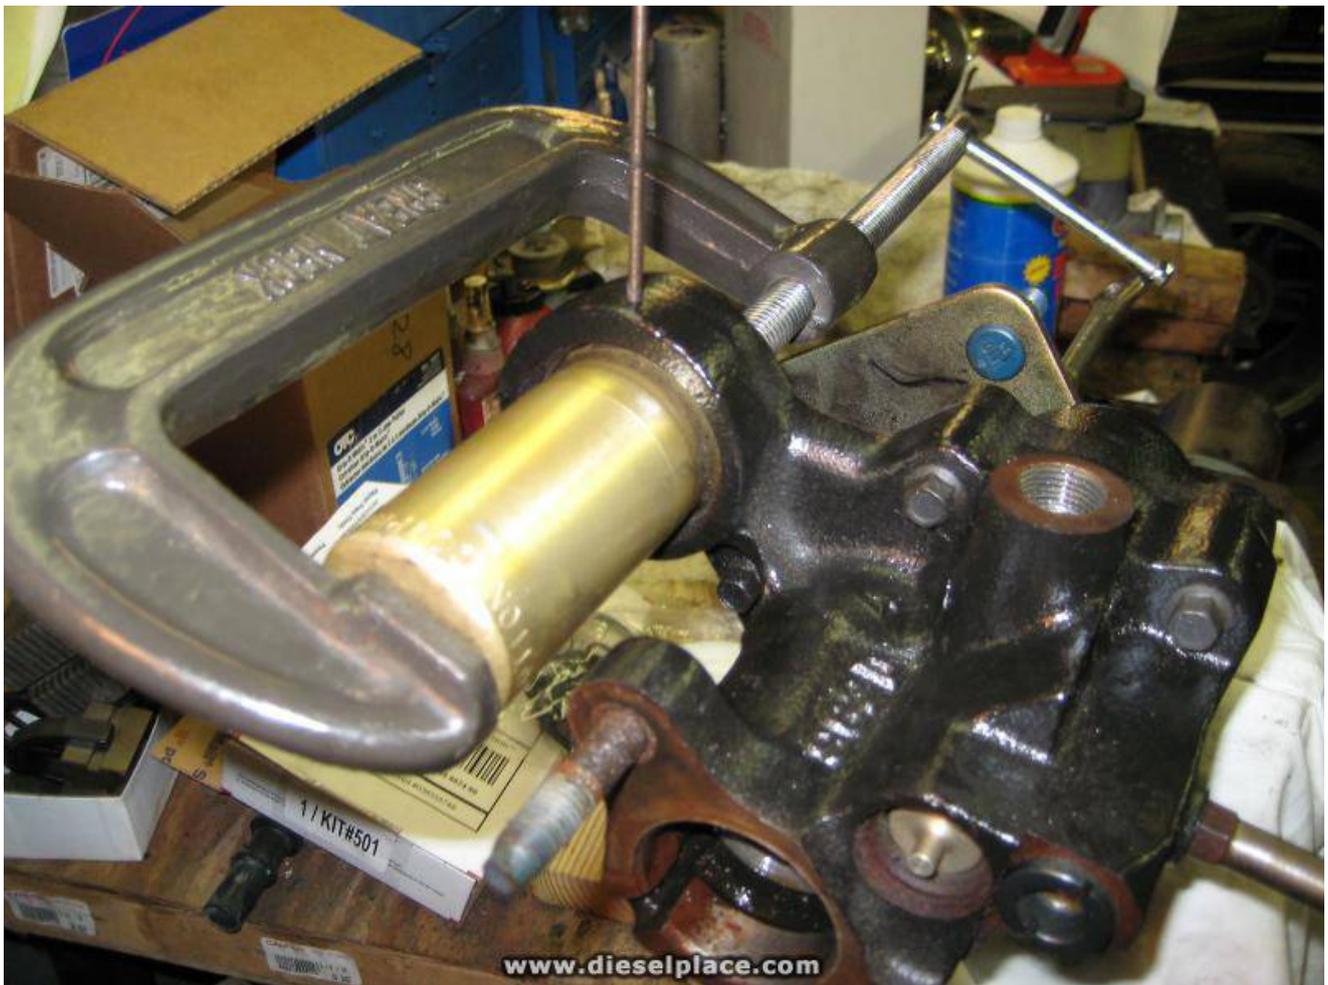
Pic 3 Removing the accumulator (note 1/8 pin punch to remove snap ring)

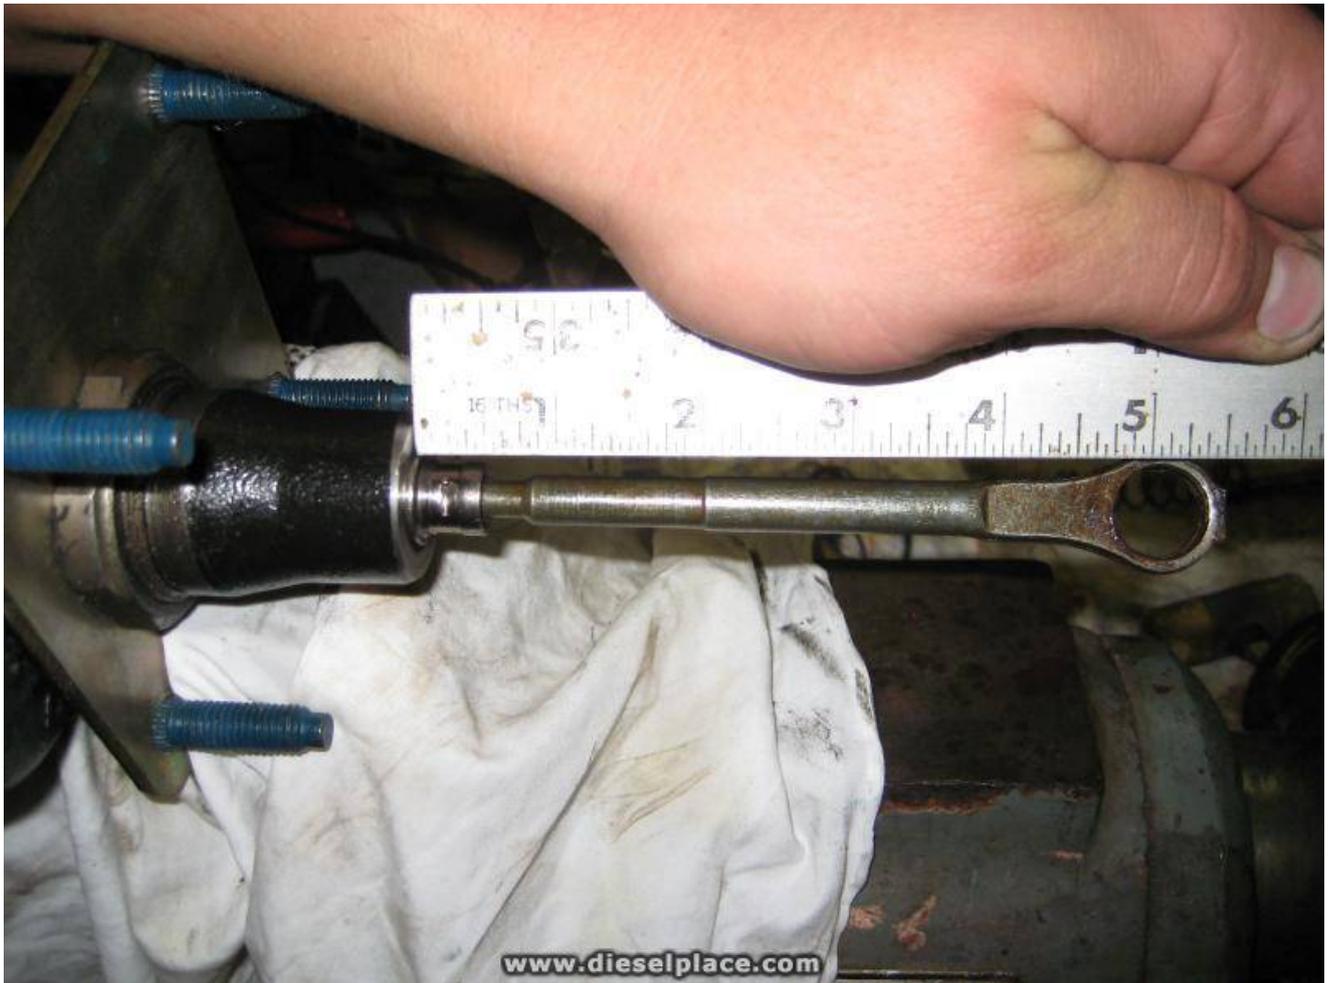
Pic 4 Take this measurement if removing input rod and replacing with adjustable unit.

We did not measure, but we probably should have, the output rod protrusion. If you were going to swap hydro boosts among vehicles you could accidentally preload the MC or have slop between output rod and master cylinder that would have to be taken up every time you use the brakes.

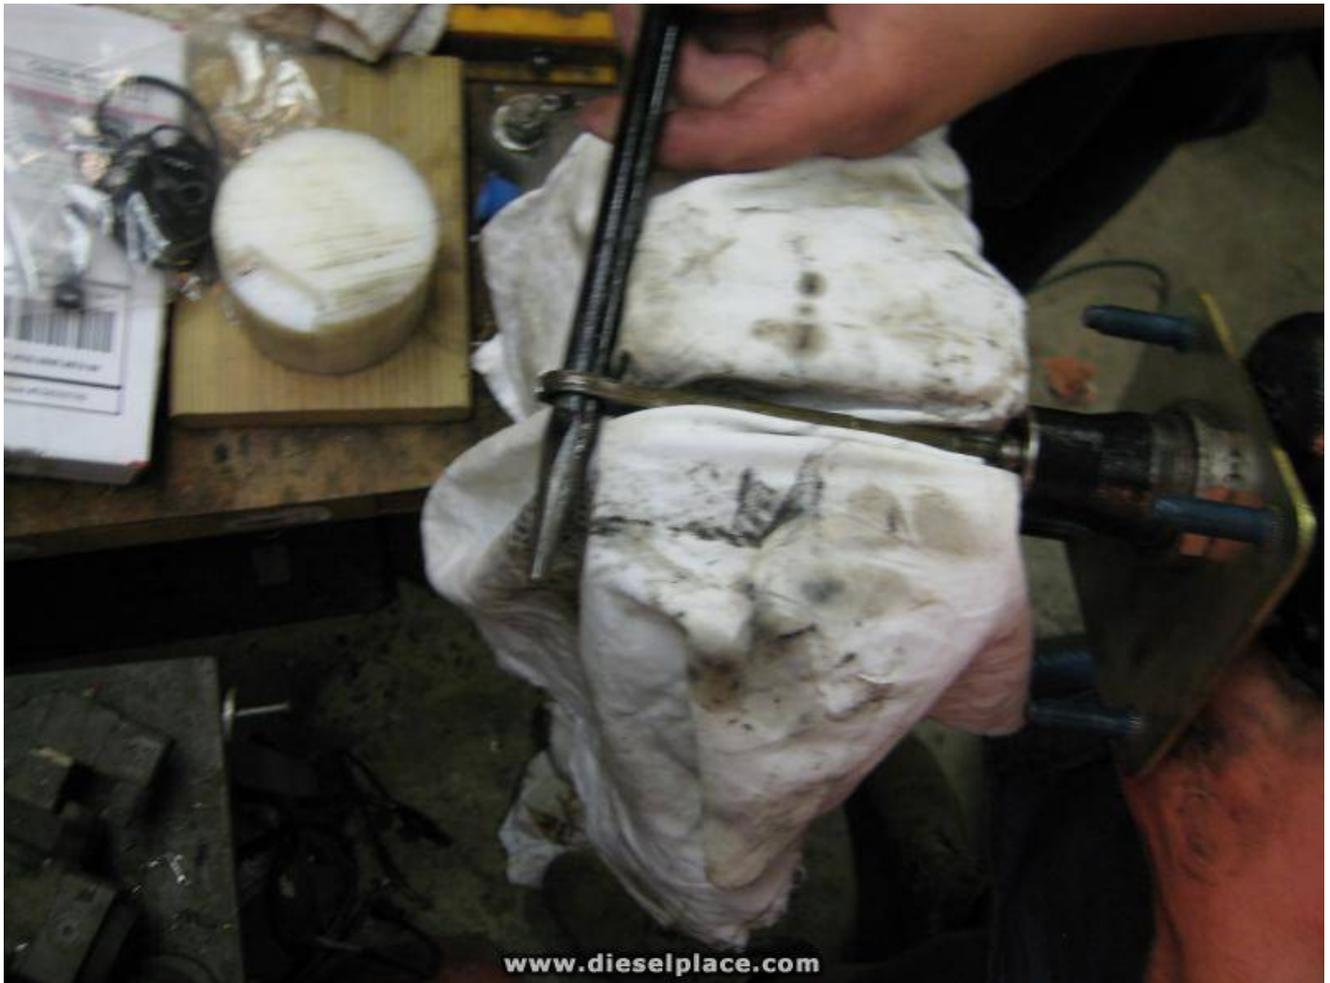
Pic 5 Removal of staked in pedal rod.

The hardest part was removal of the brake pedal rod (ok, maybe brake light switch). We decided to replace the push rod seals, so this staked in rod must be removed. This took 5 hands. (one pair holding the pump, one pair operating the pry-bar, and one person finding and holding shims for the pry bar to have a straight pull.) We should have supported the push rod. We did not, we supported the housing, but on reflection, the proper thing would have been to make a "C" shaped or slotted washer to make all

the resistive force be applied to the push rod and not pulling the whole Power piston assembly against the housing. (I will try to photo shop some pictures with an explanation.)

We tried hard, but the force required to iron out the staking distorts the pedal rod hole. The GM instructions say we should throw this pedal rod out, and install an adjustable replacement rod. I am not doing well finding this replacement rod. So we might just make ours work.

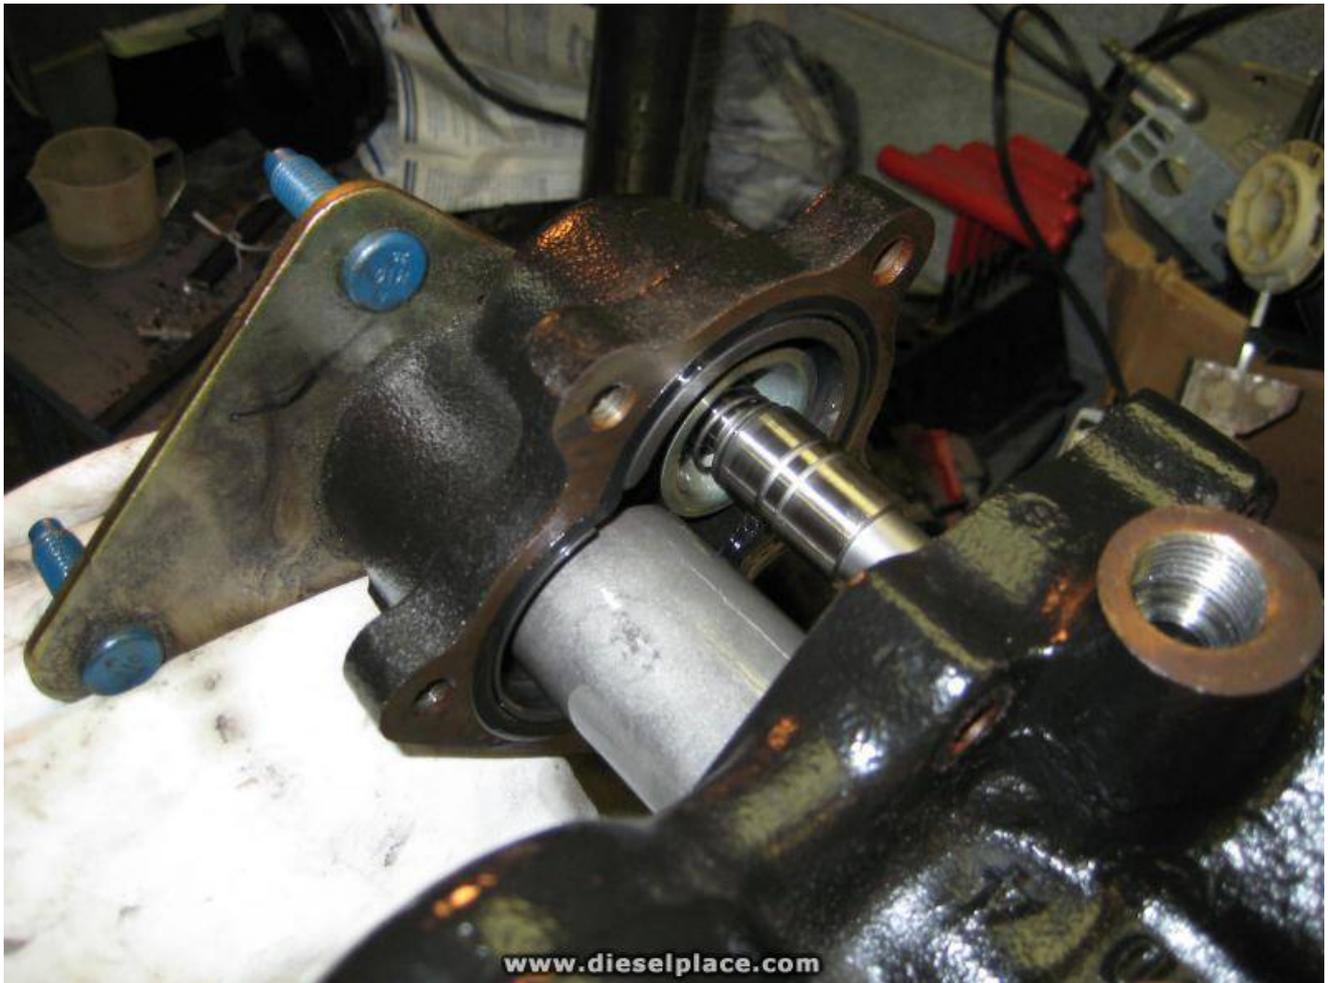
Pic 6 power Hydro halves coming apart.

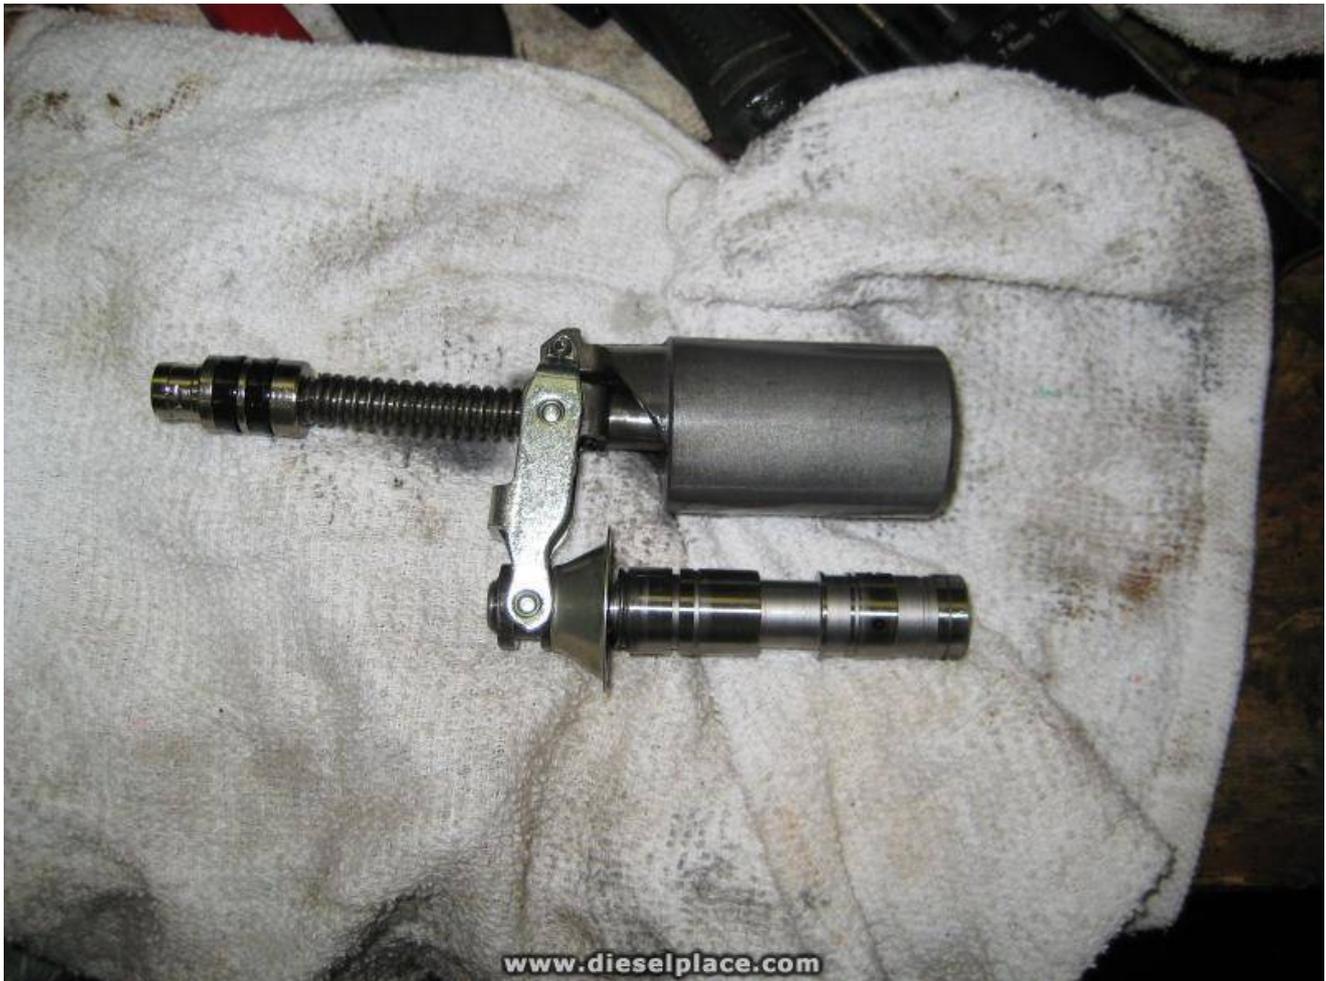
Pic 7 Push rod /Power Piston assembly w/ spool valve.

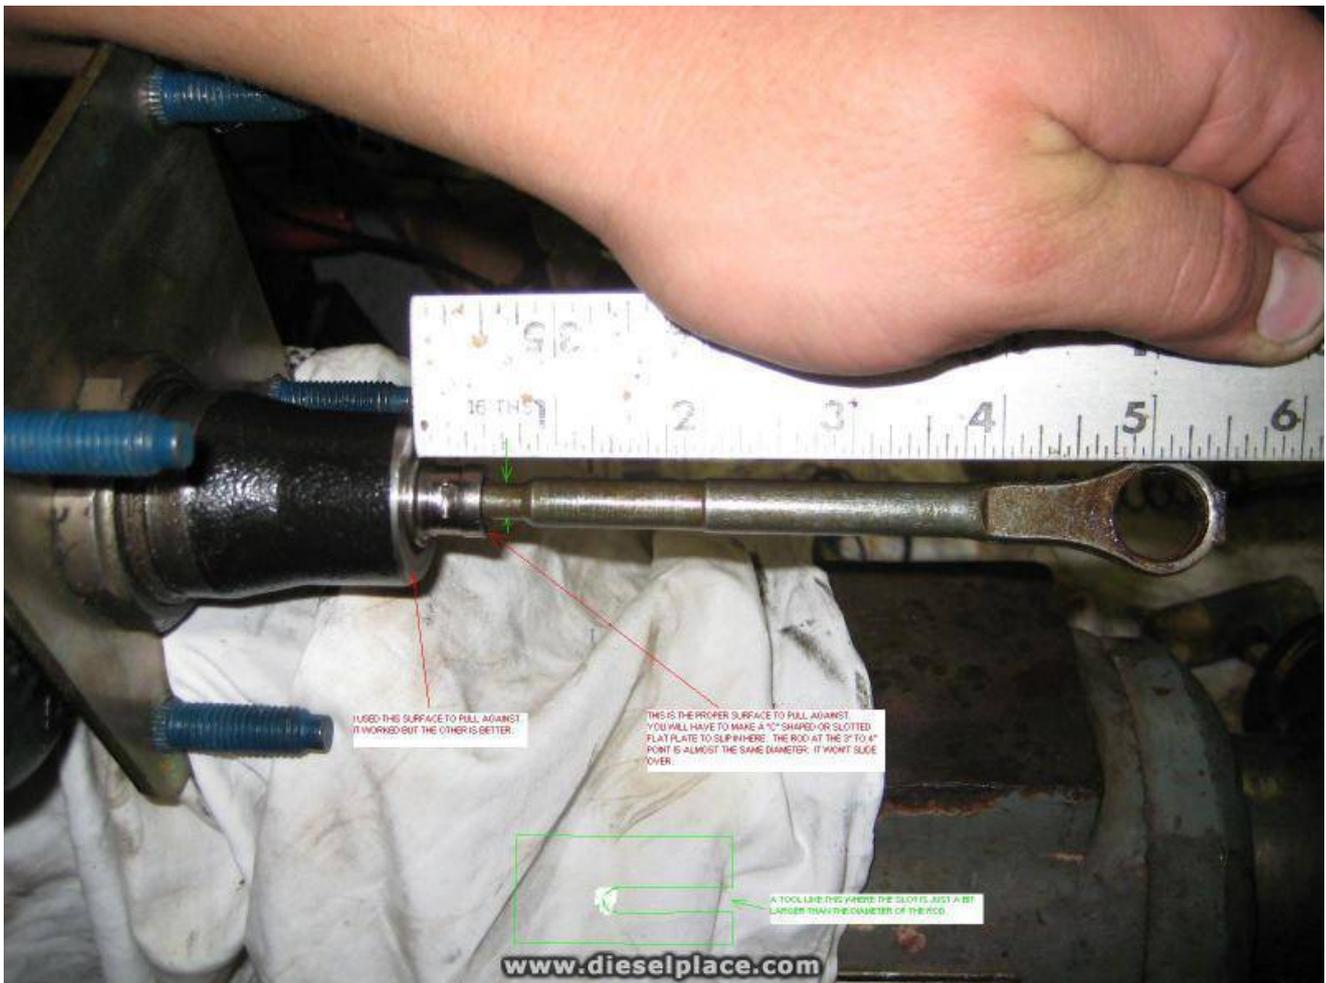
The following picture shows you the surface I pulled against, but also shows you the surface that should be pulled against. Since I used the housing, all the pulling force I applied went against the fulcrum between the spool valve and the power piston. If you make the proper slotted piece, the force to pull the ball from the stakes will be resolved ONLY in the area by the stakes.

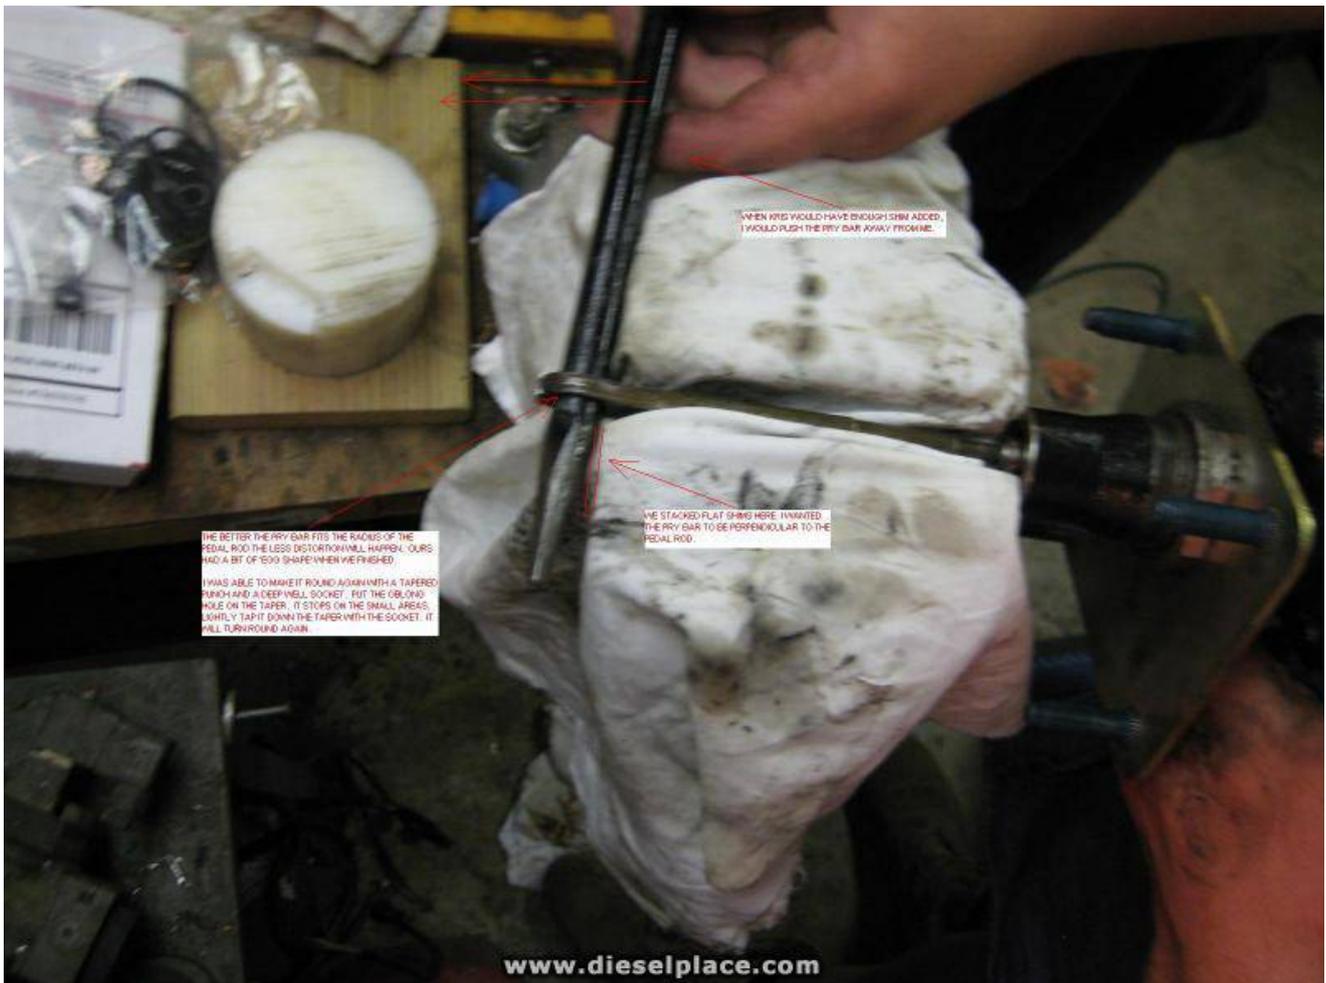
Here is a picture detailing where to put the shims to keep the pry bar perpendicular. The force required to pull it is pretty high. I know that the pry bar I was using had a pretty good amount of bend in it. (It is a cheap pry bar though) I also cannot say how helpful it was to have a couple extra hands. You can do it yourself, but you will have to make something to hold the hydroboost in place. The shims will fall every time you take pressure off the pry bar.
